Title: Product weathertightness testing of a sample of Living Wall rainscreen cladding

Report No: N950-15-17090

Customer: Biotecture Limited, The Old Dairy, Ham Farm, Bosham, West Sussex, PO18 8EH

Issue date: 9 December 2015

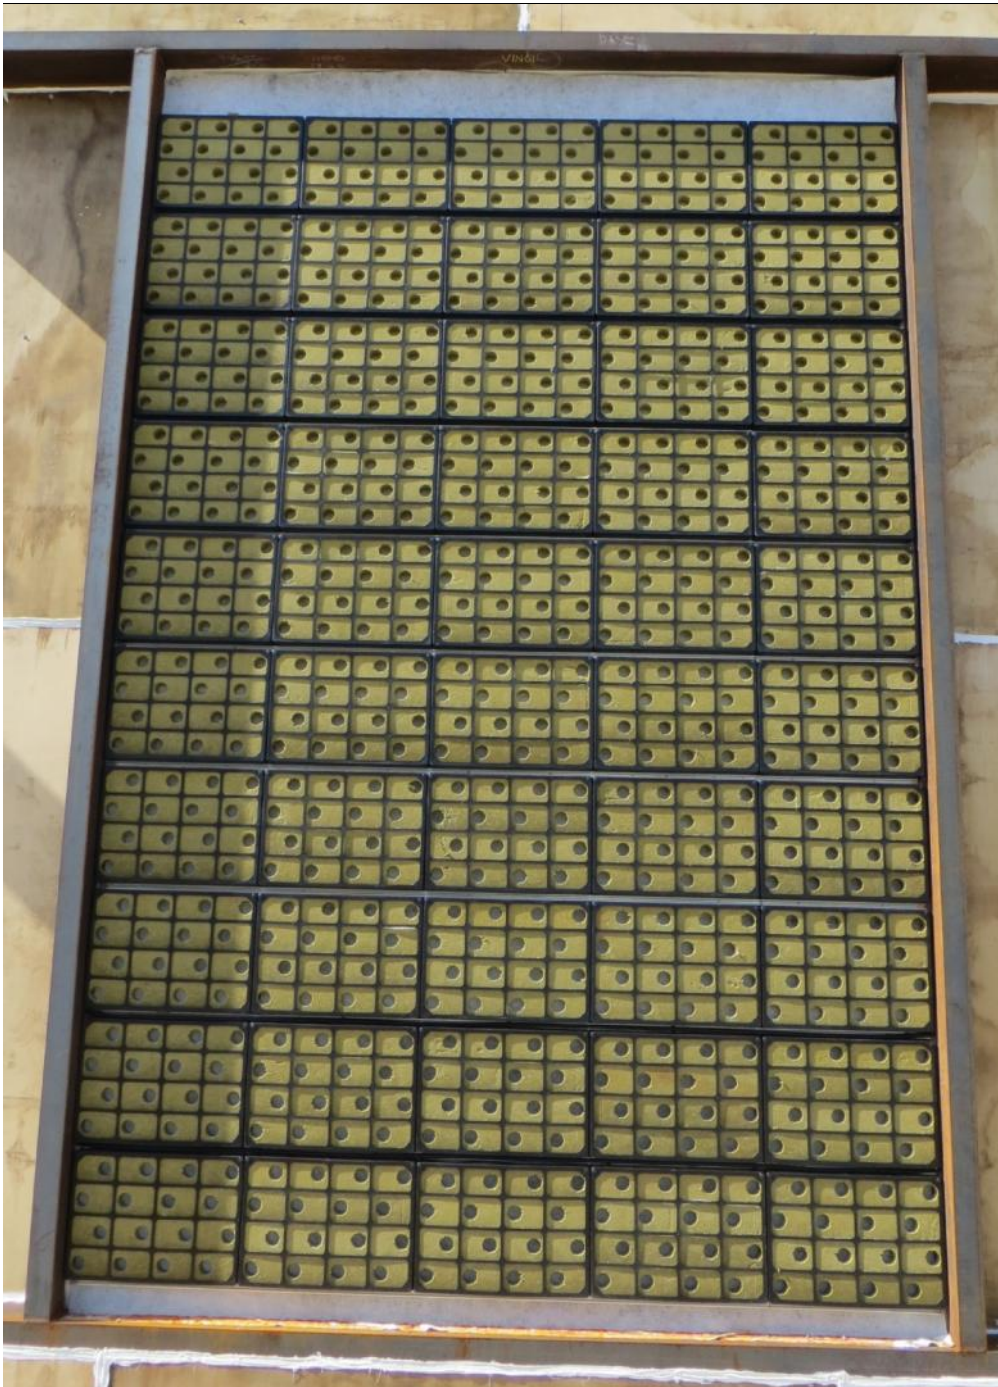
PHOTO 9129

The test sample measured 3.0 m wide by 4.8 m high and comprised 50 Biotecture 600 x 450 plant panels secured to an 8 mm thick rock panel backing wall.

TEST SAMPLE ELEVATION

The sample was as shown in the photo below and the drawings included as an appendix to this report. For details of any remedial work carried out refer to Section 7.

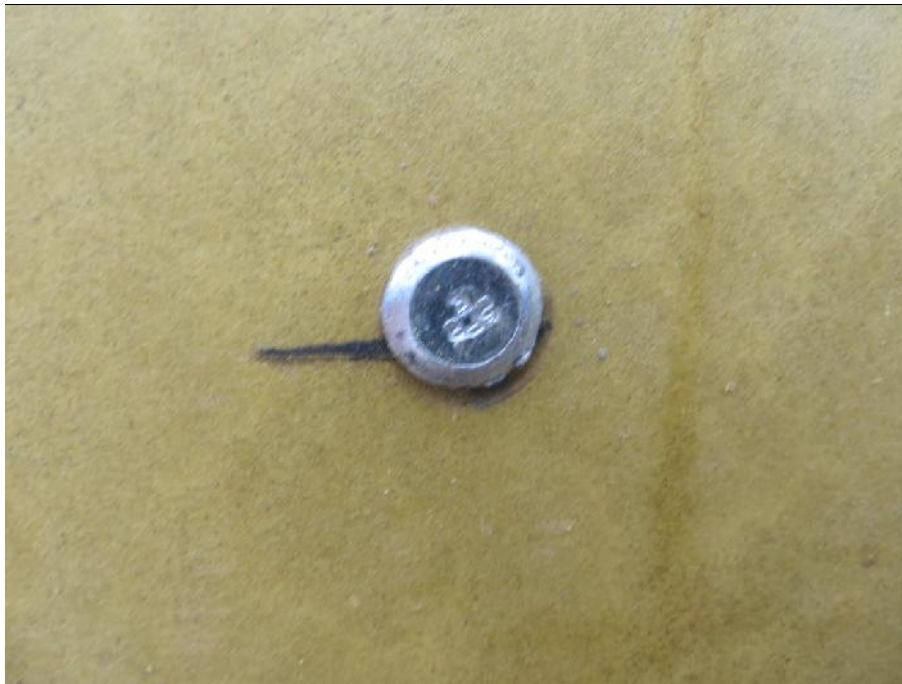
PHOTO 9840

FRONT OF ALUMINIUM PEEL RIVET

The 4.2 mm x 13 mm s/s screws holding the aluminium carrier rail to the backing board were replaced with 4.8 mm x 30 mm aluminium peel rivets.

The rivet effectively sandwiched the backing board between the carrier rail and the expanded and peeled back of the rivets.

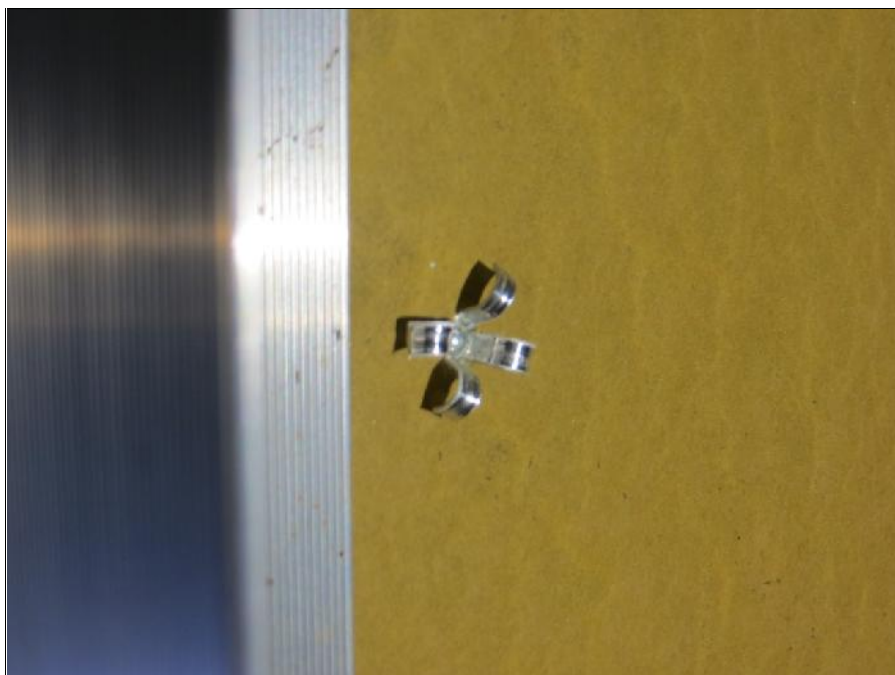
PHOTO 9828

INTERNAL VIEW OF ALUMINIUM PEEL RIVET

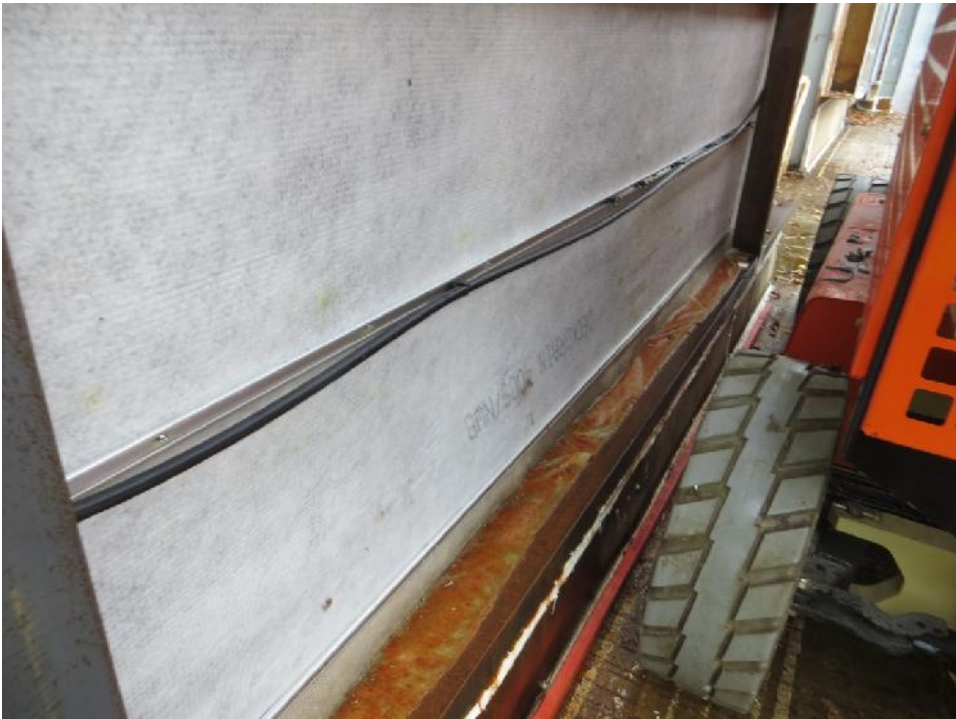
PHOTO 9833

During the dismantling of the sample no water penetration or discrepancies from the drawings were found.

SAMPLE WITH PLANT PANELS REMOVED

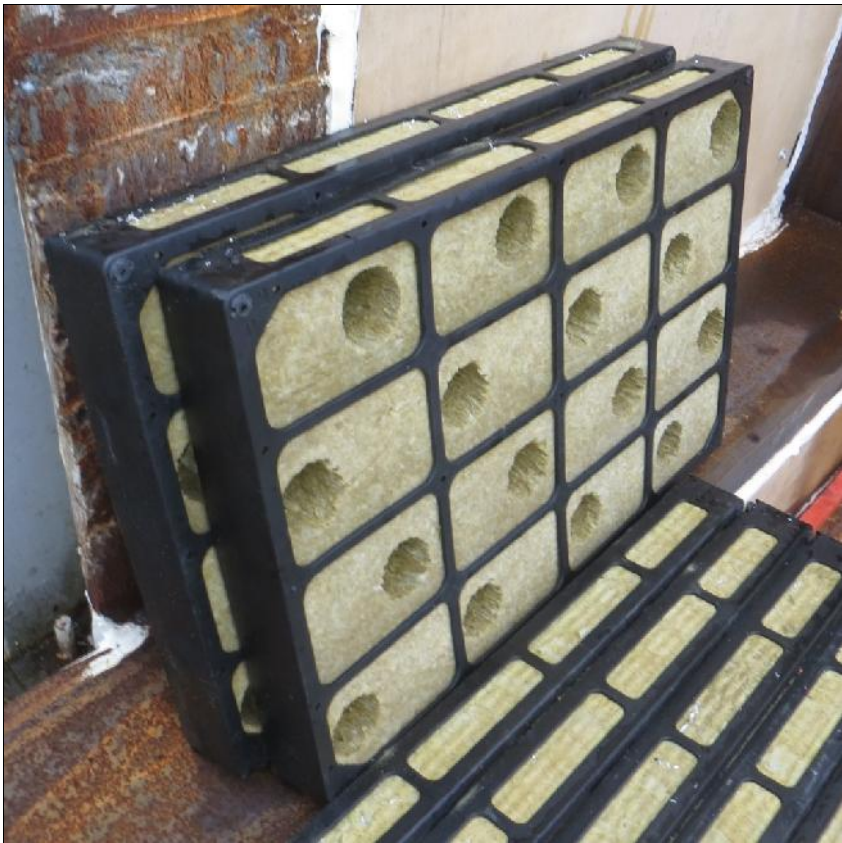
PHOTO 9834

PLANT PANELS

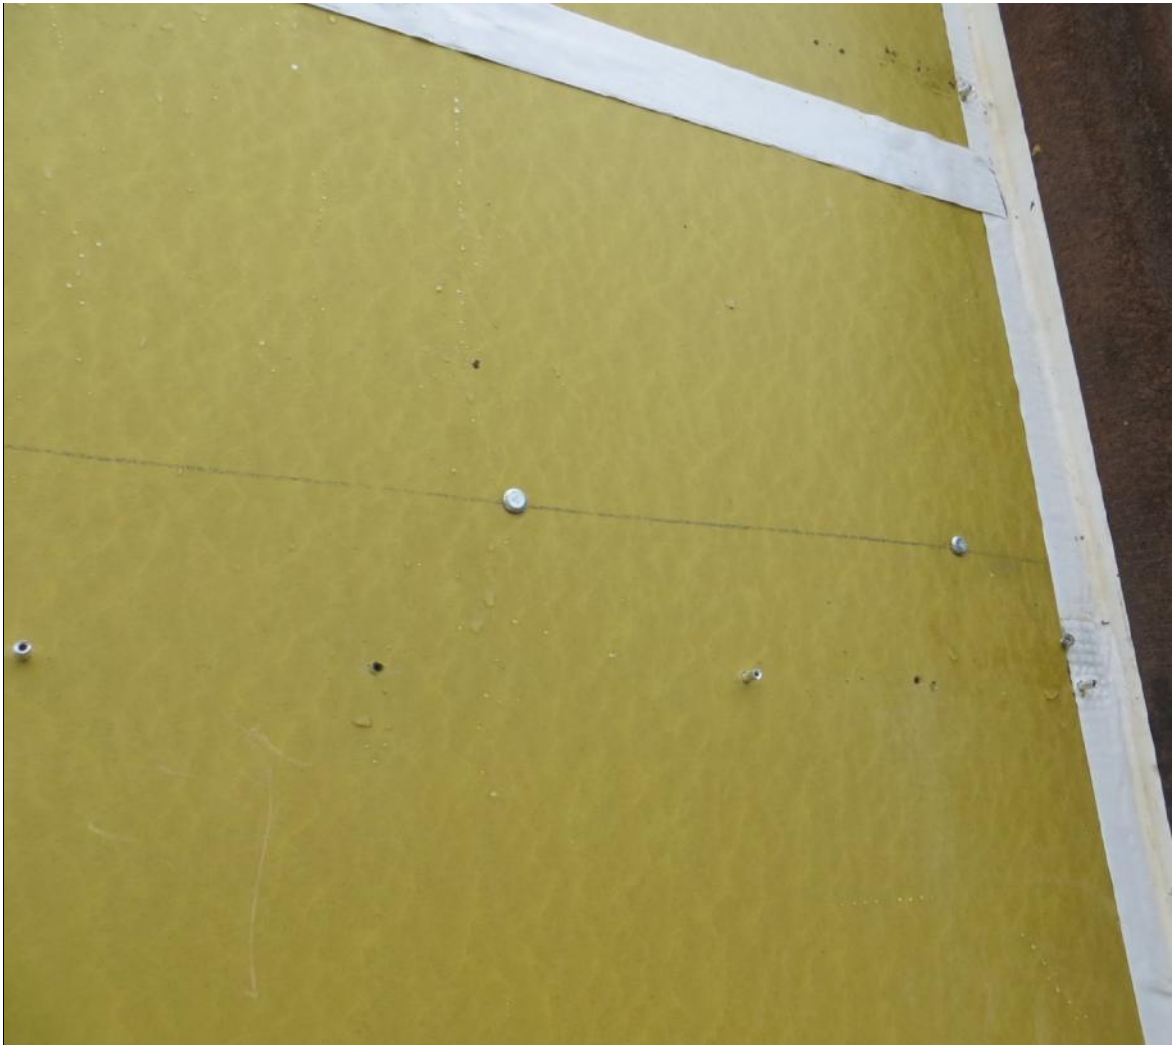
BACKING WALL

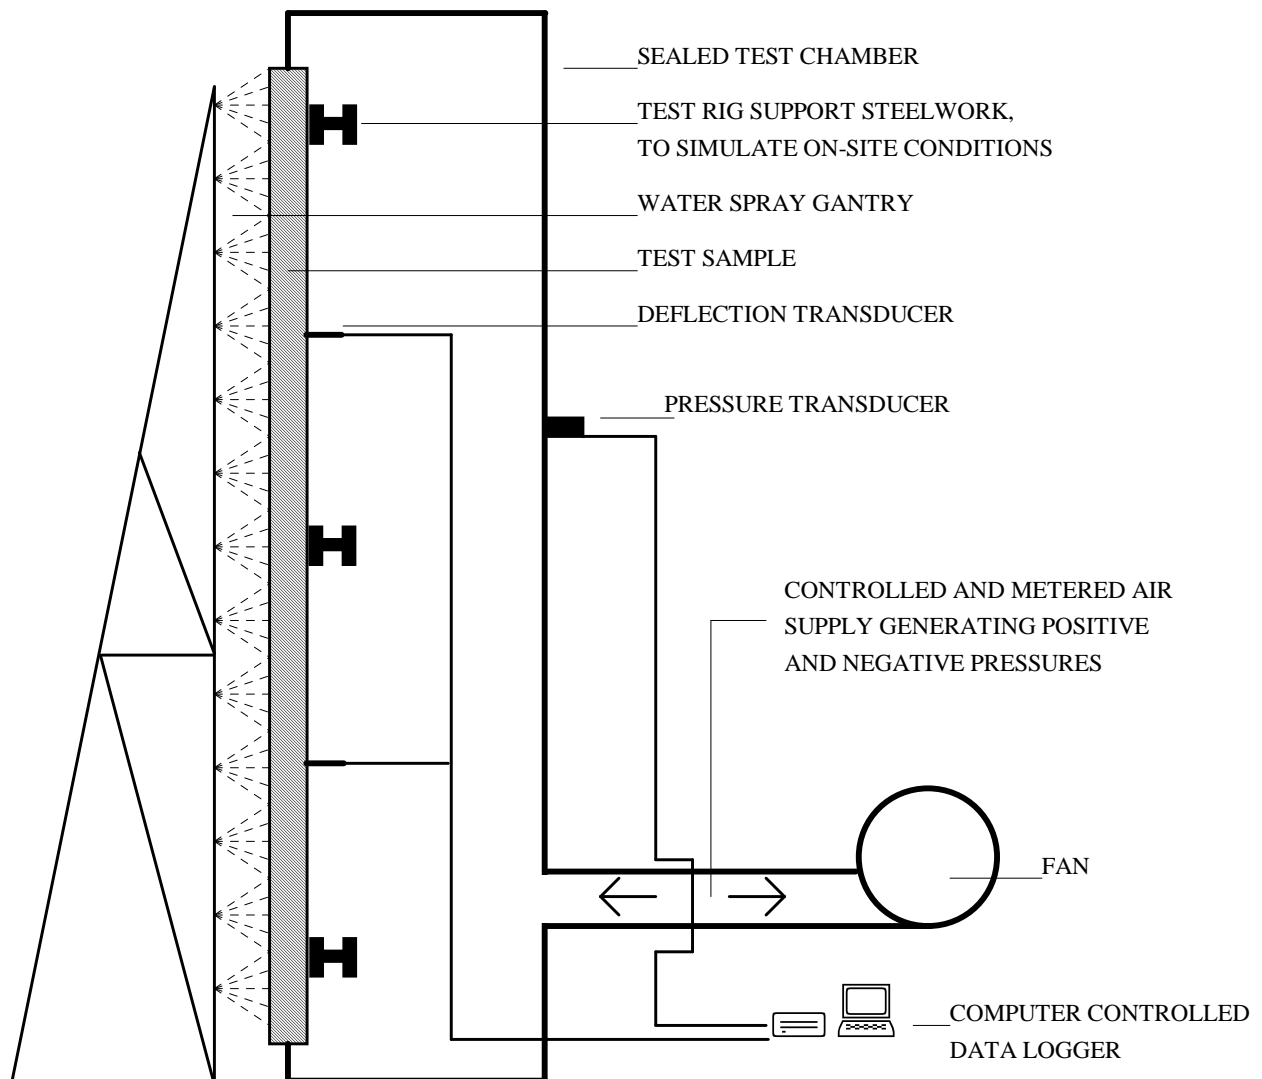
FIGURE 1

The test sample was mounted on a rigid test rig with support steelwork designed to simulate the on-site/project conditions. The test rig comprised a well sealed chamber, fabricated from steel and plywood. A door was provided to allow access to the chamber. Representatives of Biotechure Limited installed the sample on the test rig. See Figure 1.

TYPICAL TEST RIG SCHEMATIC ARRANGEMENT

SECTION THROUGH TEST RIG

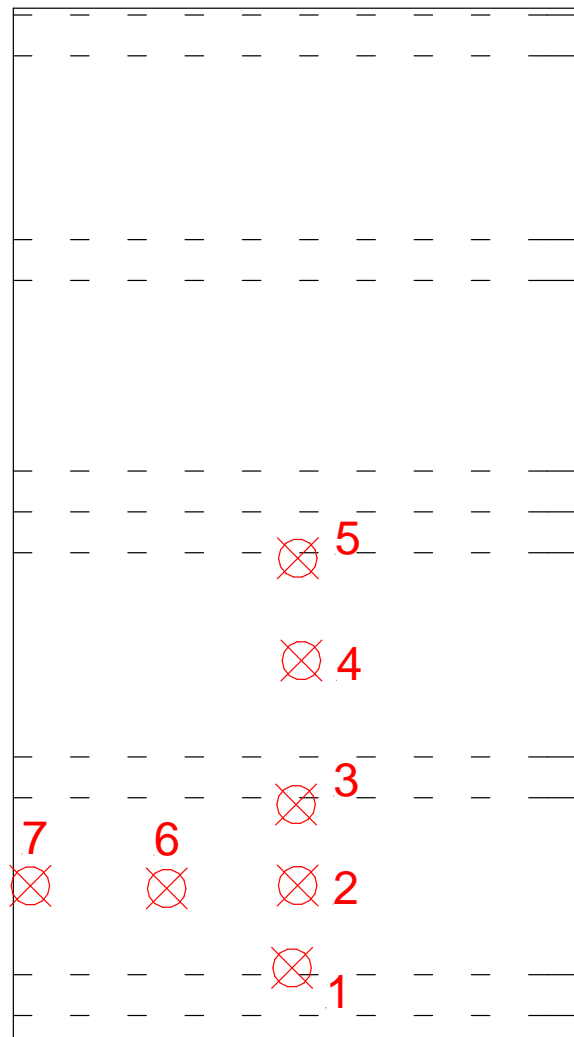
FIGURE 2

Displacement transducers were used to measure the deflection of principle framing members to an accuracy of 0.1 mm. The gauges were set normal to the sample framework at mid-span and as near to the supports of the members as possible and installed in such a way that the measurements were not influenced by the application of pressure or other loading to the sample. The gauges were located at the positions shown in Figure 2.

DEFLECTION GAUGE LOCATIONS

Internal View

Deflection gauge

Gauge number	Member	Span (L) (mm)	Permissible deflection (mm)	Permissible residual deformation
2	Internal panel	1000	$L/200 = 5.0$	1 mm
4	Internal panel	1000	$L/200 = 5.0$	1 mm
6	Internal panel	1500	$L/200 = 7.5$	1 mm

The deflections measured during the wind resistance test, at the positions shown in Figure 2, are shown in Tables 3 and 4.

The deflections measured during the structural safety test, at the positions shown in Figure 2, are shown in Table 5.

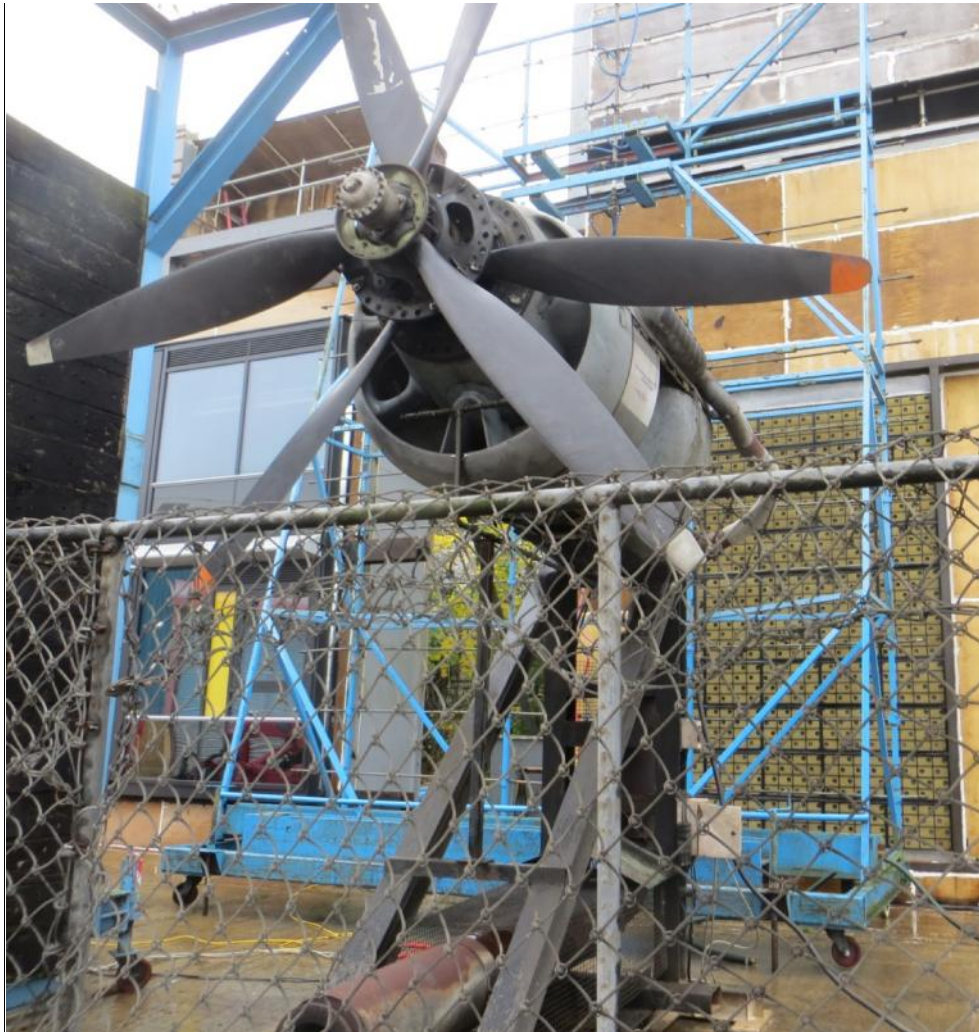
A wind generator was mounted adjacent to the external face of the sample and used to create positive pressure differentials during dynamic testing. The wind generator comprised a piston type aero-engine fitted with 4 m diameter contra-rotating propellers.

DYNAMIC WIND GENERATOR

The aero-engine was used to subject the sample to wind of sufficient velocity to produce average deflections in the principle framing members equal to those produced by a static pressure differential of 600 pascals. Suction was applied to the inside of the specimen to achieve the required test deflections but was limited to 25% of the peak static pressure. These conditions were maintained for 15 minutes. Throughout the test the inside of the sample was examined for water penetration.

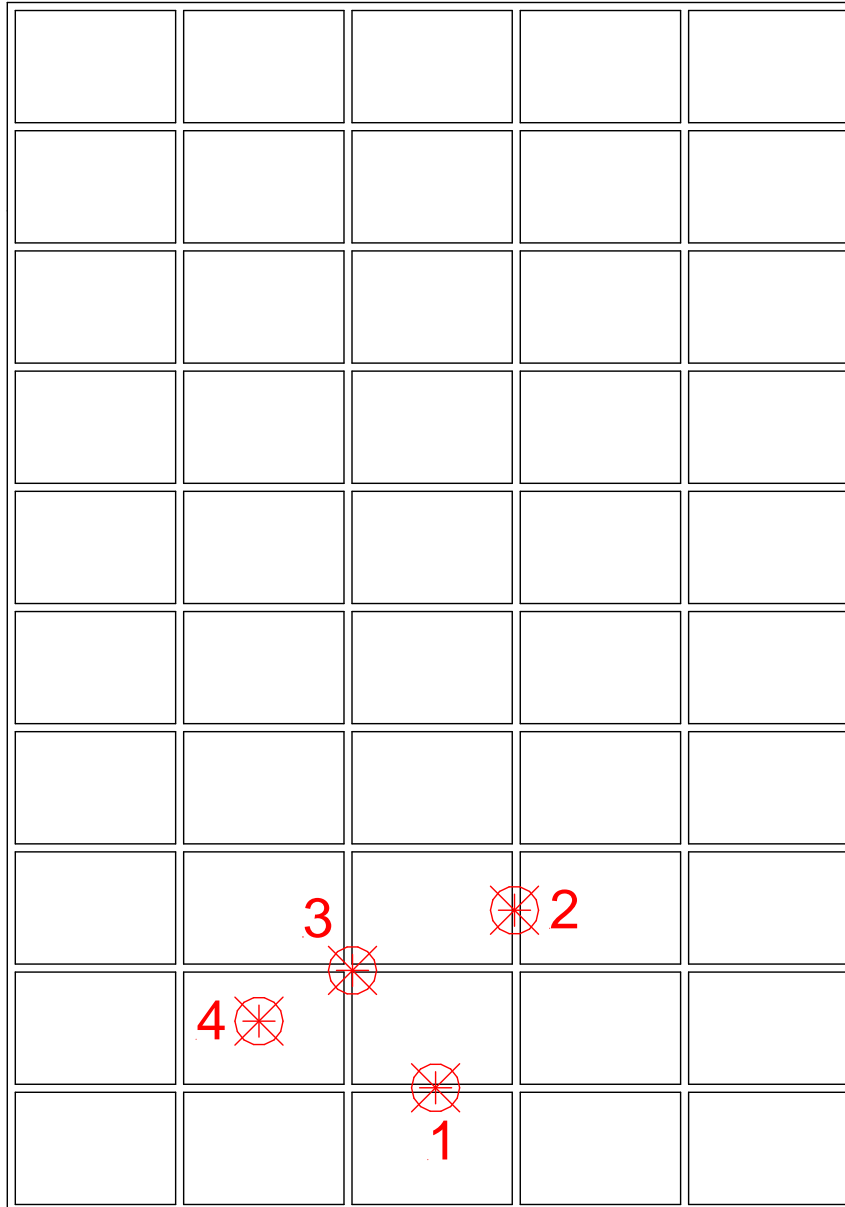
FIGURE 3

The impactor almost touched the face of the sample when at rest. It was swung in a pendular movement to hit the sample normal to its face. The test was performed at the locations shown in Figure 3. The impact energies were 120 Nm for serviceability and 350 Nm and 500 Nm for safety.

IMPACT TEST LOCATIONS

External View

Impact location

No damage to the sample was observed.

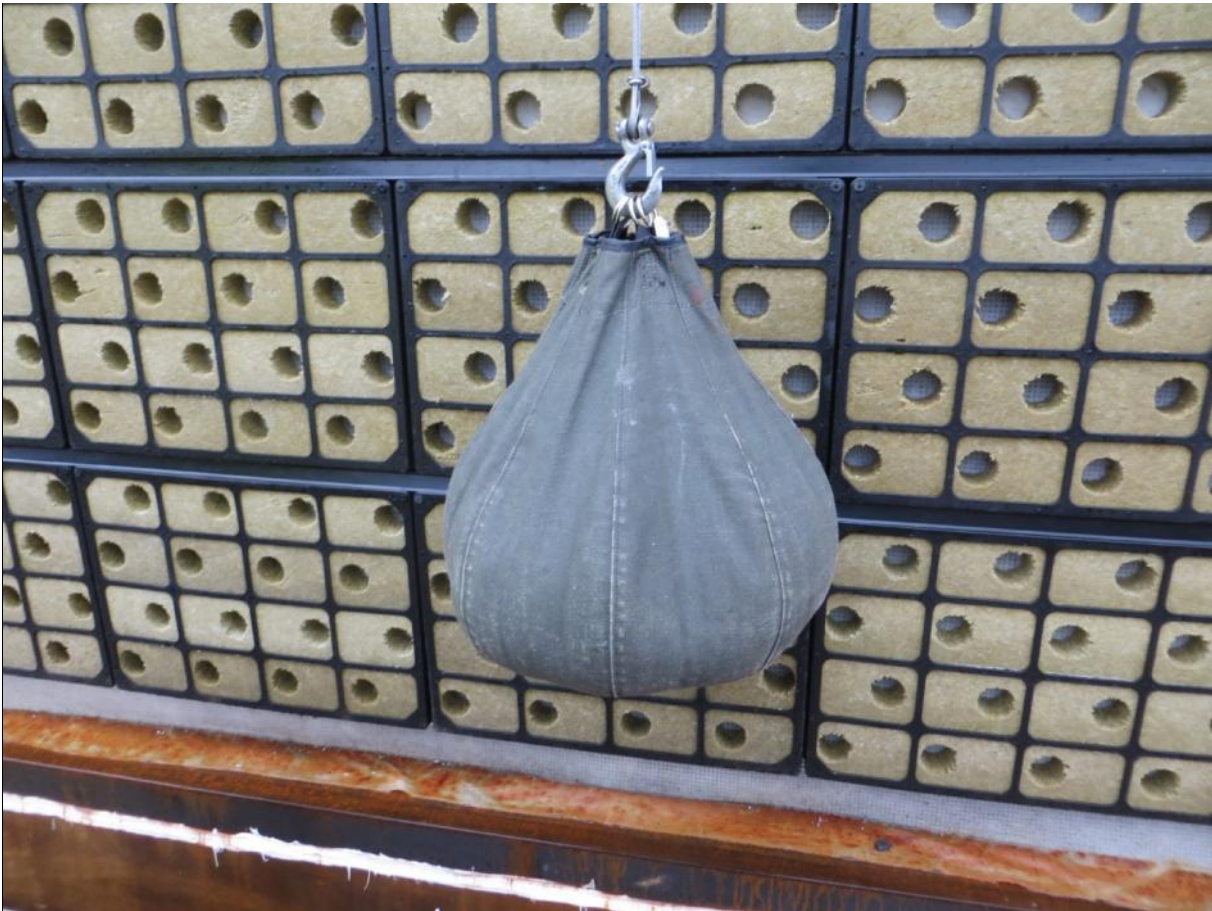
PHOTO 9827

The soft body impactor comprised a canvas spherical/conical bag 400 mm in diameter filled with 3 mm diameter glass spheres with a total mass of approximately 50 kg suspended from a cord at least 3 m long.

IMPACTOR

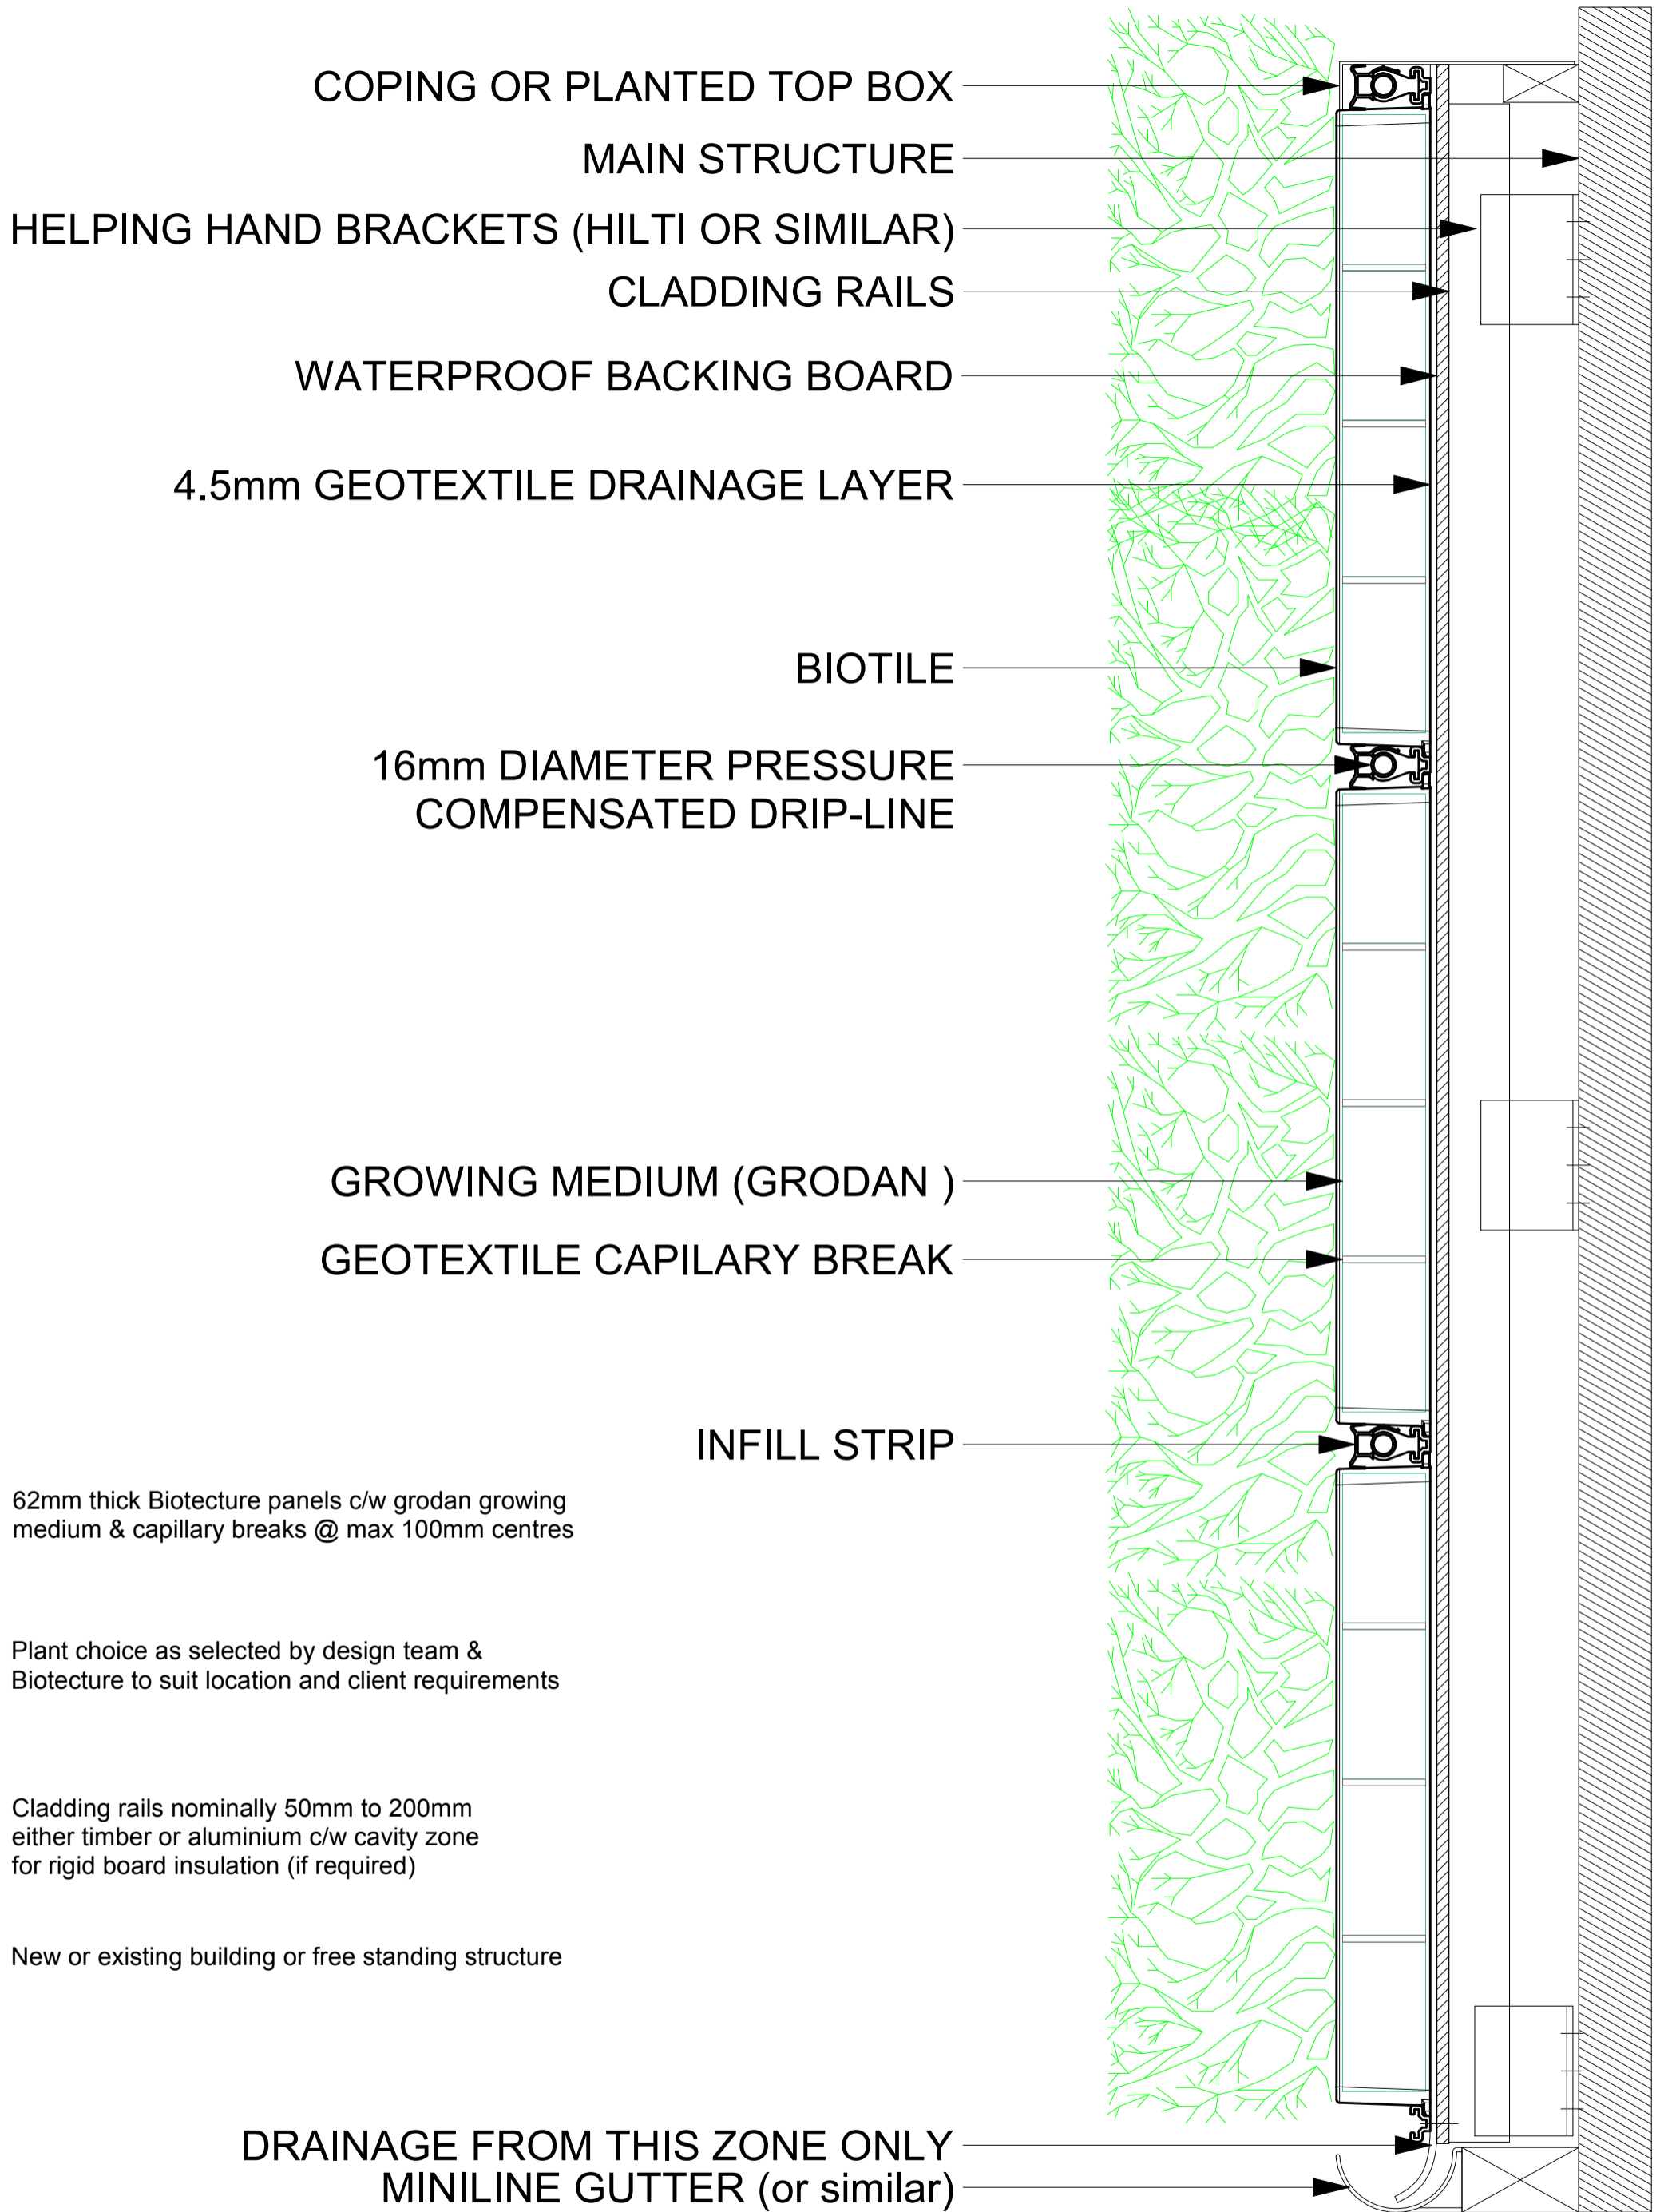
Client: BIOTECTURE
 Project:
 Title: BIOTILE STANDARD PANEL SIZES

Date: 21/04/15
 Drawn: SB
 Checked:
 Drawing No: BIO-PL-01
 Revision: A

The following 3 unnumbered pages are copies of Biotecture Limited drawings numbered:

BIO-PL-01 rev A and 2 unnumbered pages.

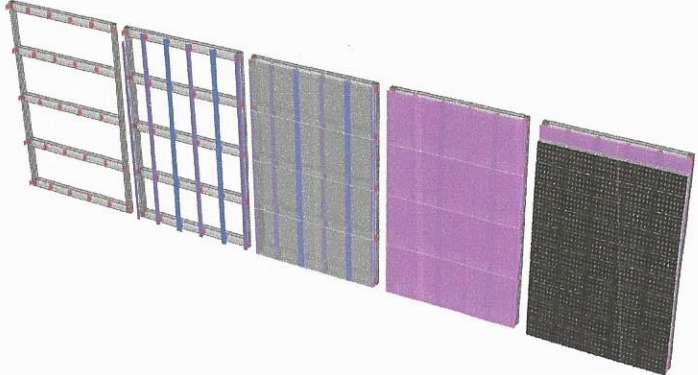
62mm thick Biotecture panels c/w grodan growing medium & capillary breaks @ max 100mm centres

Plant choice as selected by design team & Biotecture to suit location and client requirements

Cladding rails nominally 50mm to 200mm either timber or aluminium c/w cavity zone for rigid board insulation (if required)

New or existing building or free standing structure

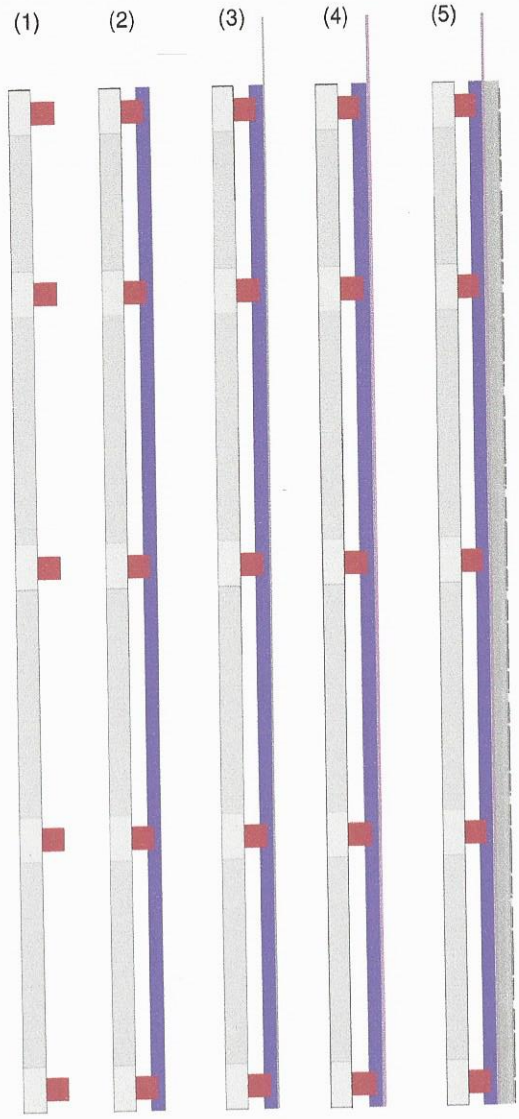
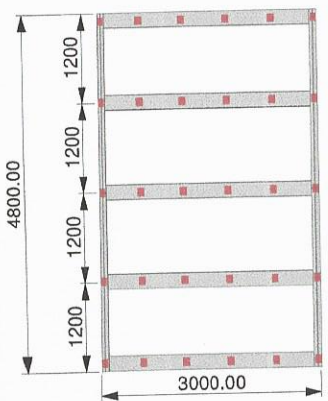
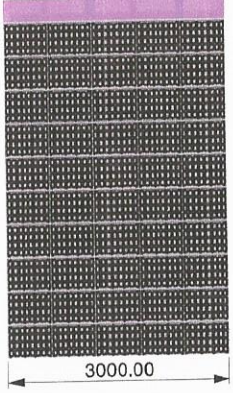
HELPING HAND BARACKETS
(1)

HILITI 'L' AND 'T' PROFILE
(2)

8MM ROCK PANEL (3000X1200MM)
(3)

4MM VOID FORMER
(4)

BIOTECHTURE 600X450
PLANTED PANELS
(5)

Client:
WIND TESTING
Project:
WIND TESTING
Title:
ELEVATION
