**LABORATORY TESTING OF BUTTON FIX
SYSTEM**

BUTTONFIX LIMITED

TEST CERTIFICATE

STRENGTH TESTING OF BUTTON-FIX SYSTEM

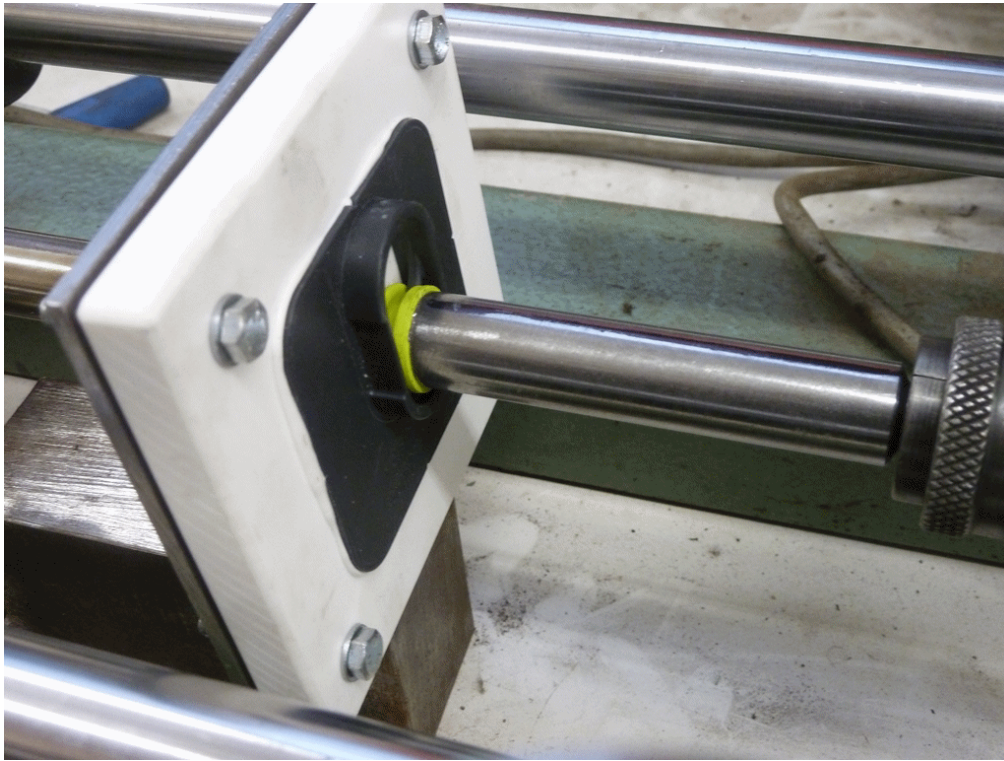
Photograph 3 A view showing the test set up for surface mounted 85 degrees from vertical (tension) test.

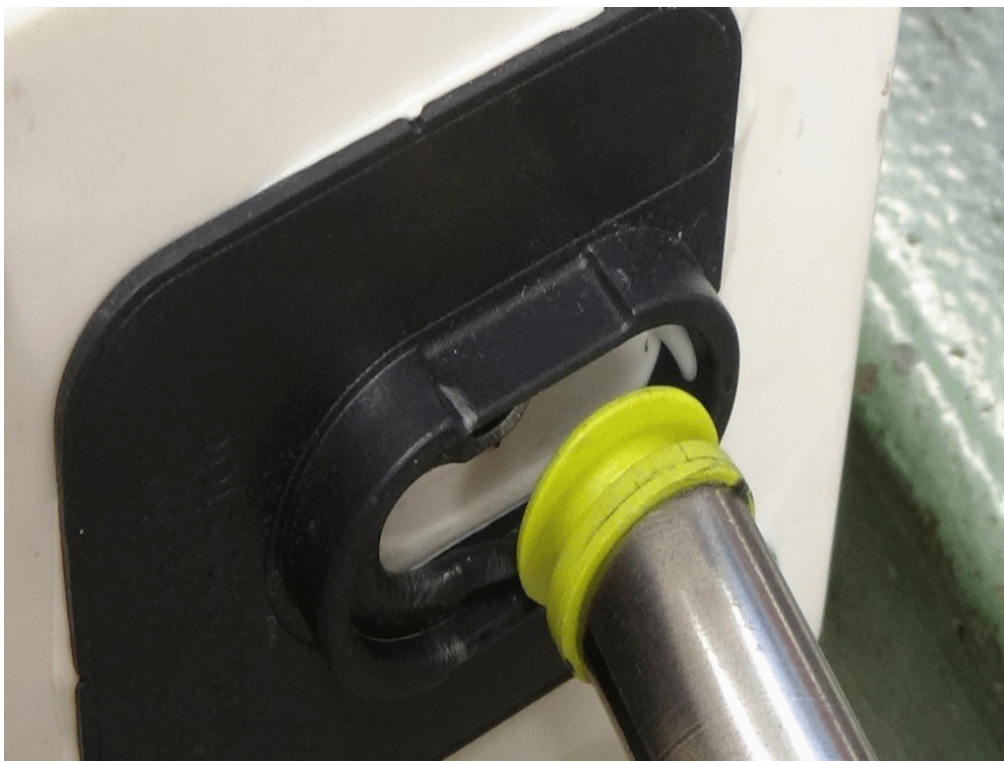
Photograph 4 A view showing the 85 degrees from vertical test failure mode. The mount material surrounding and the button distorted, allowing the button to be pulled from the mount.

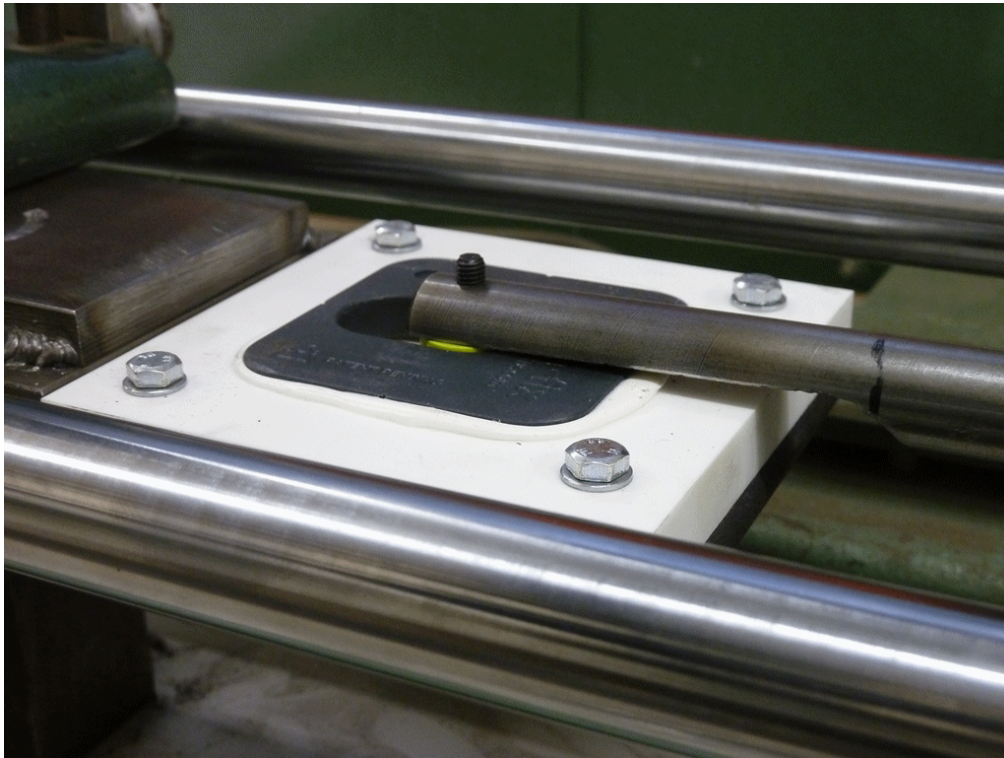
Photograph 5 A view showing the test set-up for rebate mounted vertical (shear) test.
