Fire Resistance Testing

Report: Chilt/IF11058 AR1

A fire resistance test performed on 2 No. steel access panels, one within a blockwork wall construction and one within a section of a suspended ceiling construction

Test conducted in accordance with BSEN 1634 – 1: 2008 and BSEN 1364 – 2: 1997

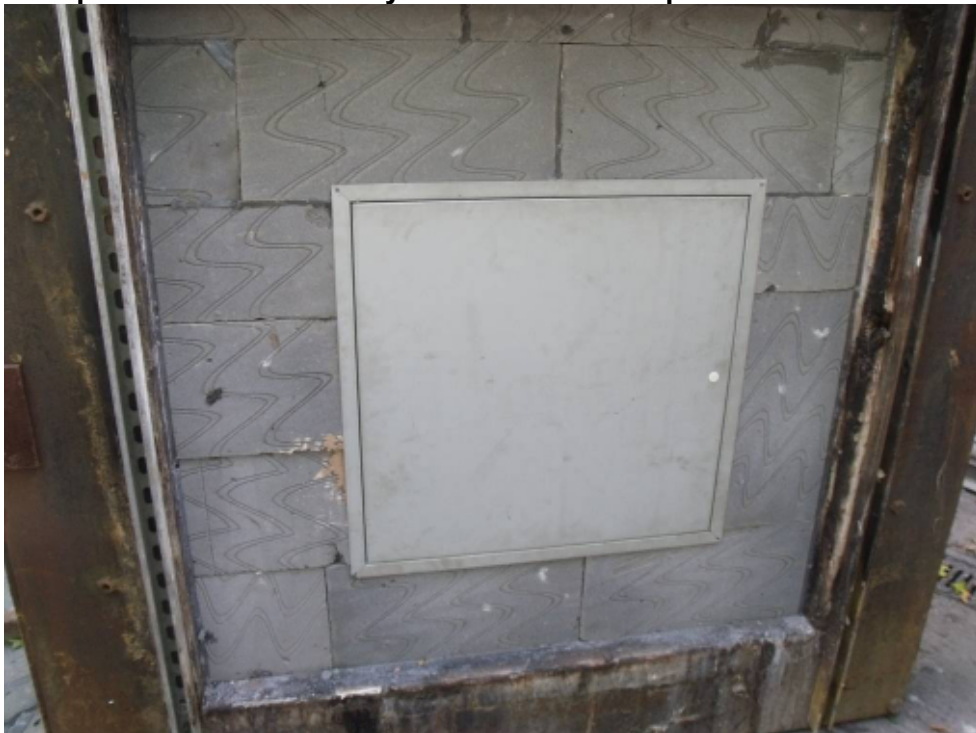
Unexposed face of vertically orientated access panel

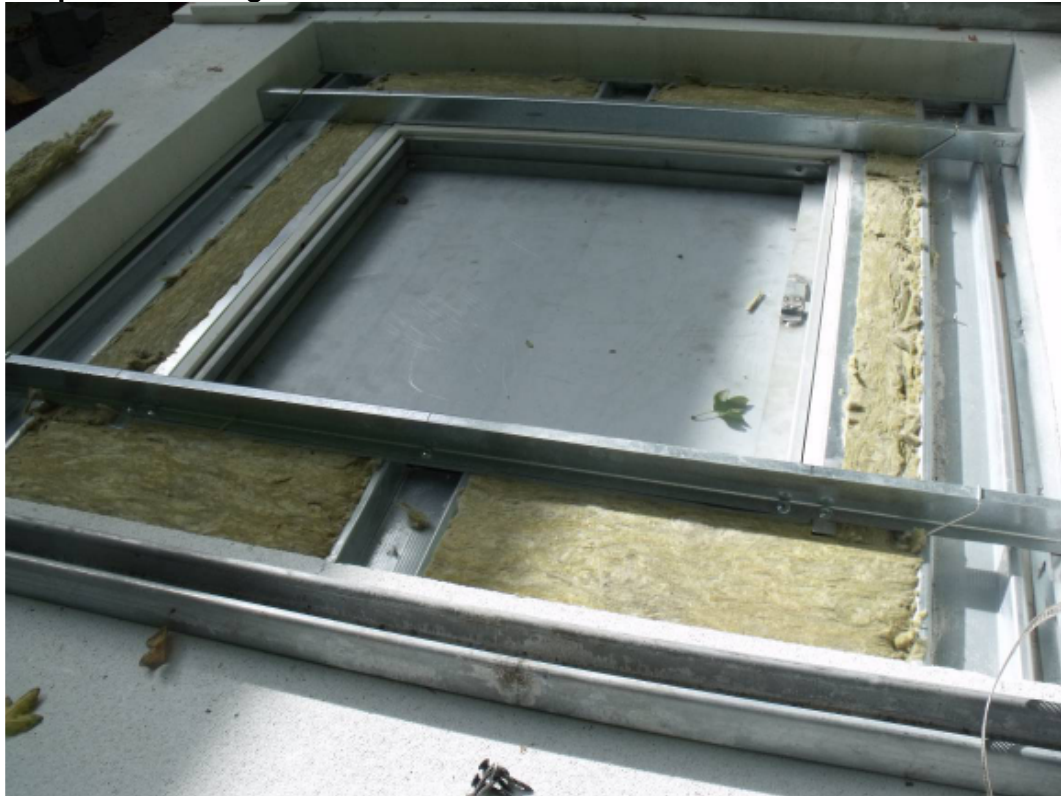
Unexposed face of horizontally orientated access panel fitted in suspended ceiling section

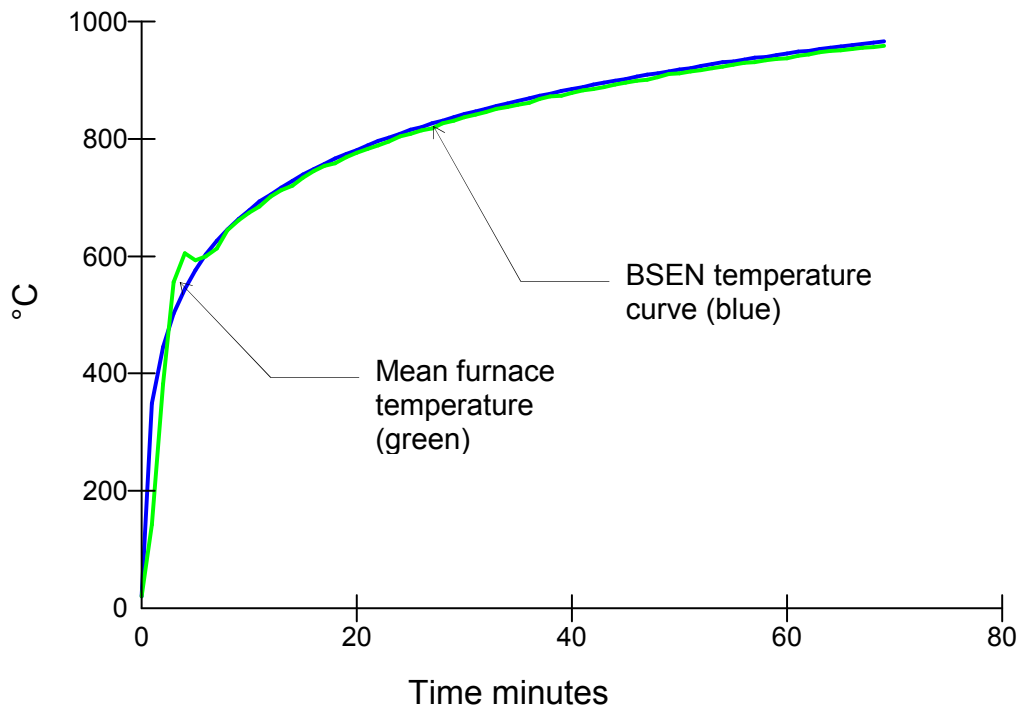
The furnace was controlled to follow the temperature/time relationship specified in BSEN 1363: Part 1: 1999 Section 5.1.1 as closely as possible, using the average of four plate thermometers suitably distributed within the furnace. The temperatures recorded have been tabulated in Appendix 2 and are shown graphically below:

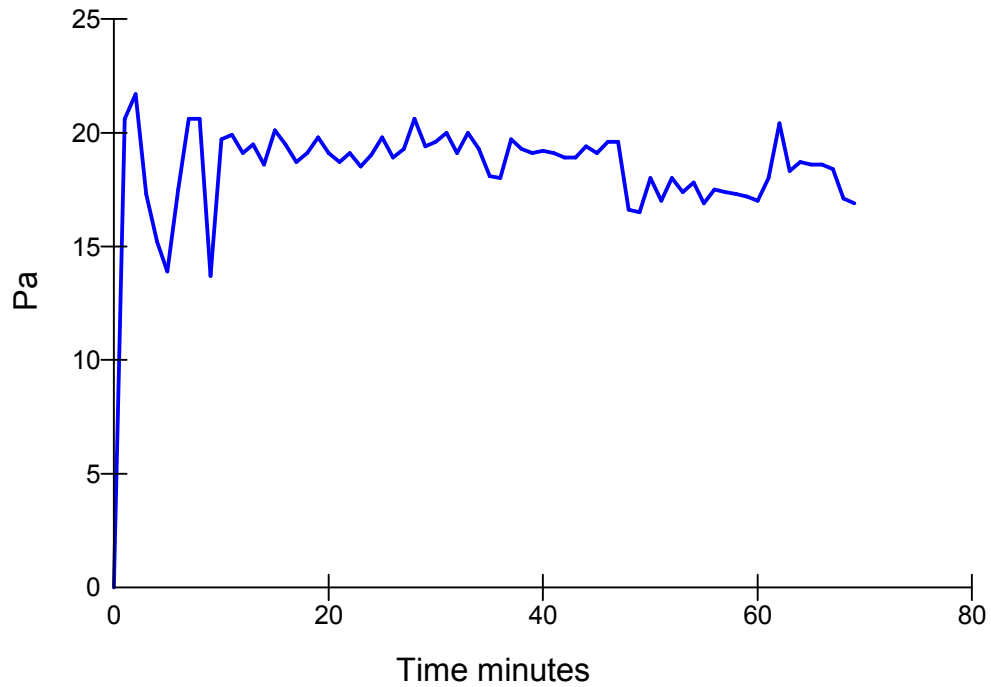
After the first 5 minutes of the test, the furnace pressure was maintained at 18 ± 5 Pa and after 10 minutes was maintained at 18 ± 3 Pa with respect to atmosphere, at a point 1.2m from the notional floor level, equating to 20 Pa at the underside of the ceiling access panel. The pressure readings have been tabulated in Appendix 2 and are shown graphically below:

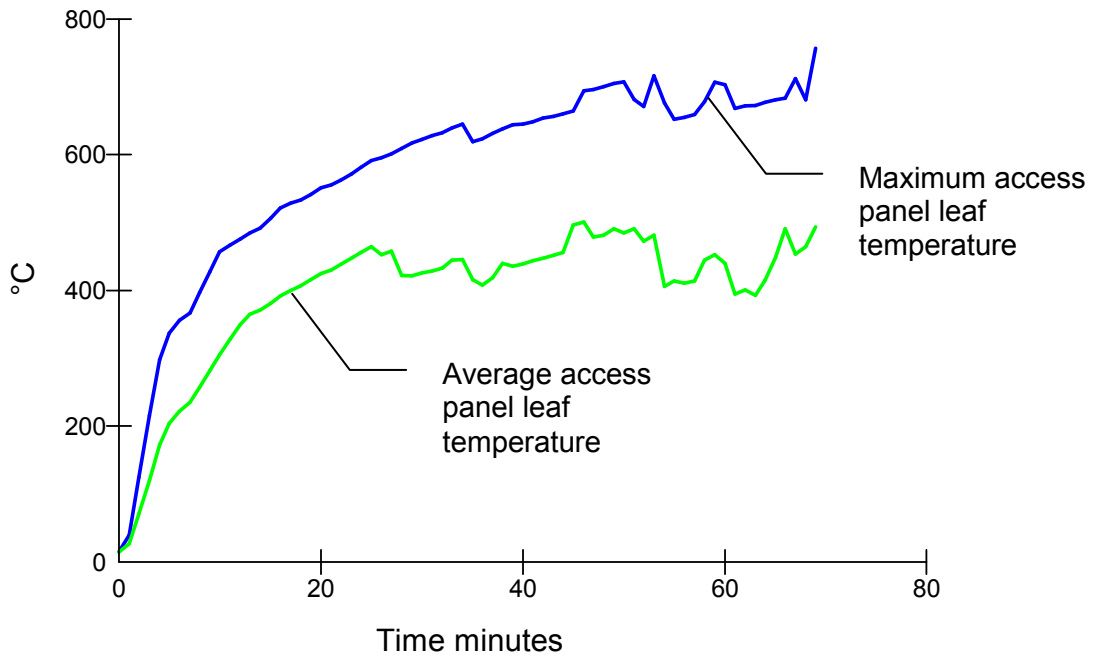
Vertical access panel

Five thermocouples were fixed to the unexposed face of the horizontal access panel leaf, and eight thermocouples were fixed to the unexposed face of the vertical access panel, three to the frame and five to the panel leaf. The temperature readings have been tabulated in Appendix 2 and are shown graphically below:

| Leaf: Maximum | 2 (two) minutes |
| Average | 2 (two) minutes |
| Frame: 180°c rise | 9 (nine) minutes |
| 360°c rise | 35 (thirty five) minutes |

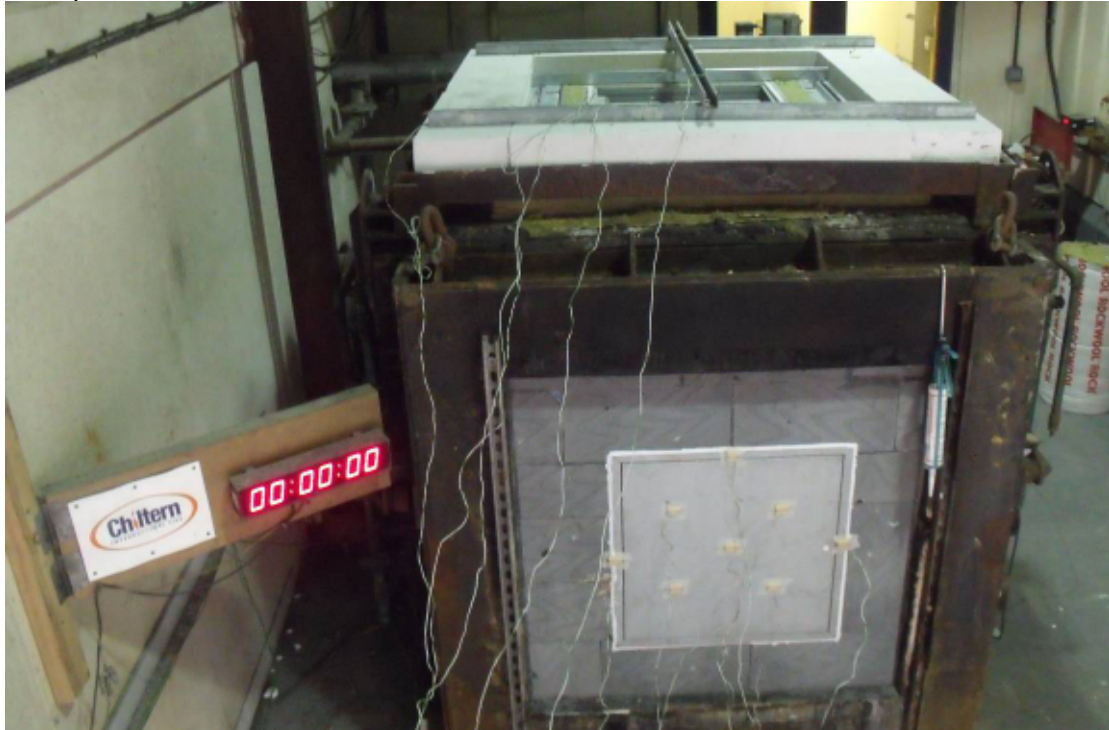
Unexposed face at start of test

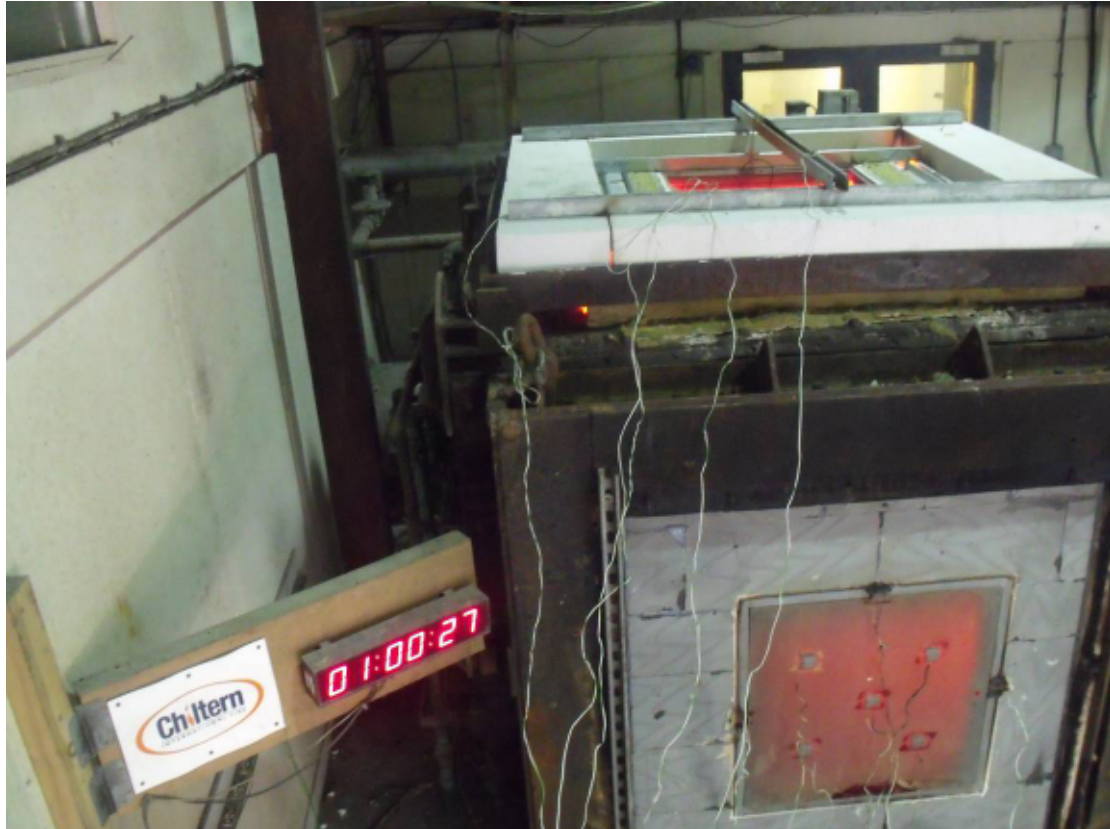
After 60 minutes

| Time (minutes) | Comments |
|---|---|
| 67.50 | There is continuous flaming from the back of the right hand side corner of the ceiling construction, where a section of plasterboard has fallen away into the furnace, thereby constituting integrity failure. |
| 69.00 | Test terminated. No integrity failure to the front vertical access panel. |

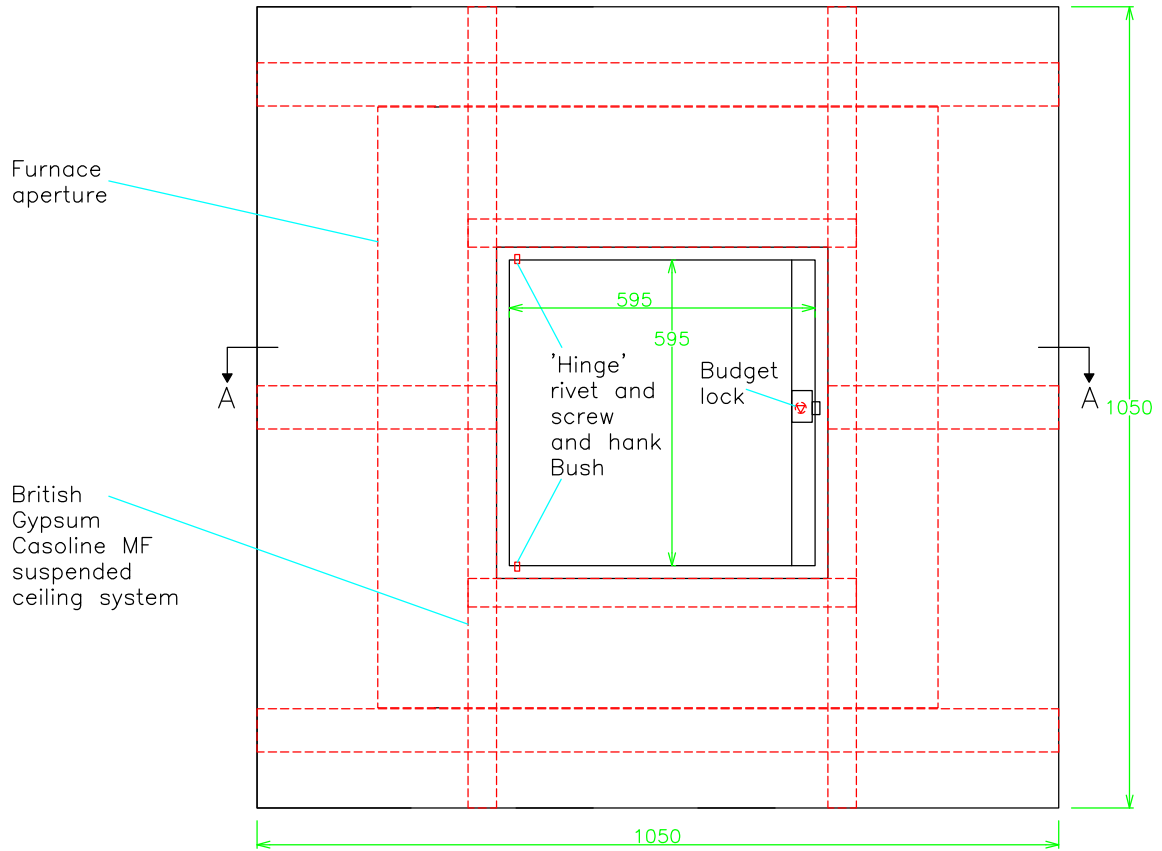
Title Unexposed face front elevation and plan view
 (All dimensions in mm)

Plan View

Front elevation

(To be read in conjunction with Figures 1 and 2)

The access panel consisted of a leaf and frame. The leaf 'tray' was manufactured from folded 0.9mm thick Zintec steel welded at the corners. The leaf was 25mm deep and had a 10mm wide return on the hanging and side edges and a 40mm wide return on the closing edge, in order to house the locking mechanism.

The frame comprised profiled 1.2mm thick Zintec steel, 50mm deep with a 25mm frame surround and 12mm deep x 25mm wide integral stop on the closing frame jamb.

The leaf was hinged to one side on an M5 x 8mm long rivet pin, and to the other side with an M5 x 12mm long pan head screw locating into an M5 @Hank Bush in the frame.

A zinc plated steel Budget lock within a 40mm wide x 40mm deep x 25mm high steel capping channel was welded to the leaf tray. The lock nib measured 20mm wide x 5mm thick and was engaged by being rotated over the frame profile. The lock was engaged for the test.

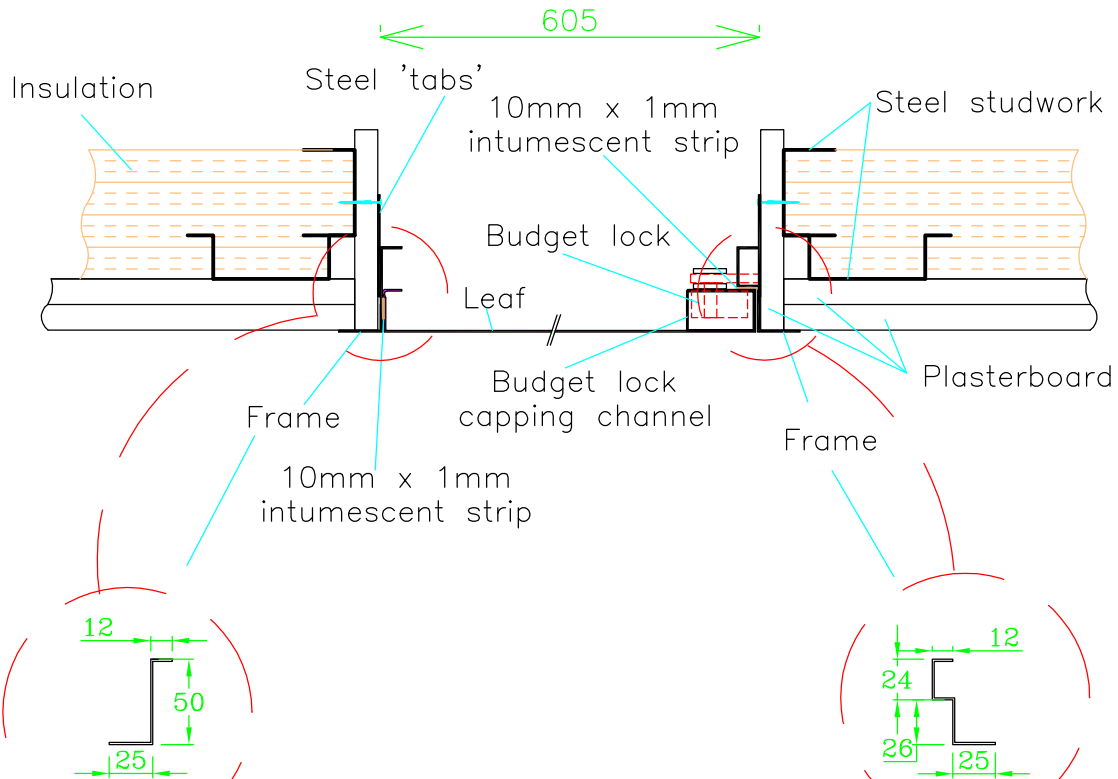
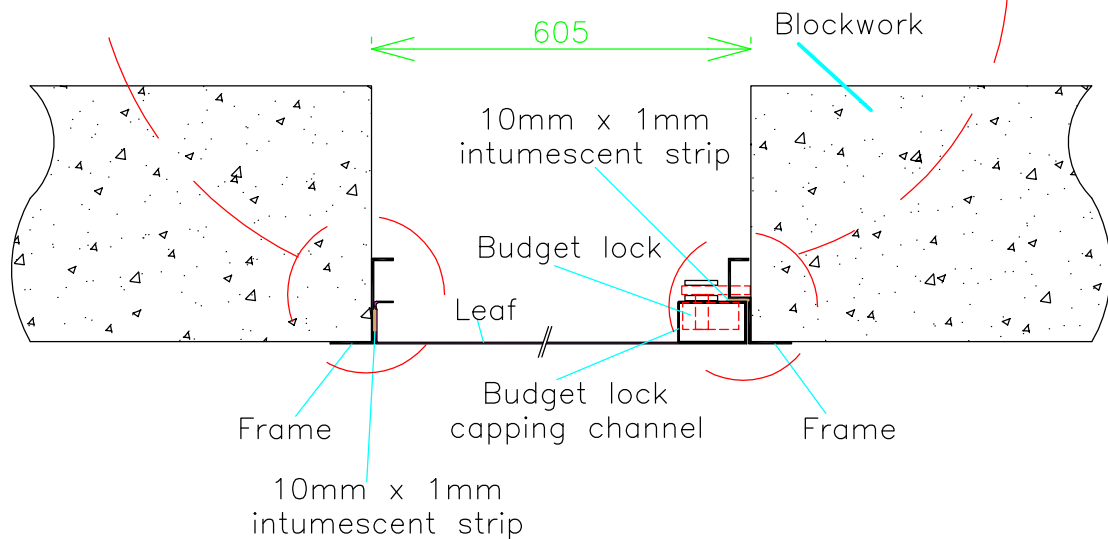
Title
 Cross sections of access panels
 (All measurements in mm)

Section A - A

Section B - B

The vertical panel frame fixed into the aperture with 2No. 80mm long masonry fixings on the horizontal edges, fitted 50mm from the corners, and was sealed to the aperture with intumescent mastic on both faces. The horizontal panel frame was fixed to the plasterboard clad steel stud framing the aperture, the panel framing having 2No. 35mm wide x 60mm high steel 'tabs' welded to each frame section and fixed to the steel studs with 2No. 25mm long drywall screws per 'tab'.

A self adhesive Envirograf (G8/10) graphite type intumescent seal, 12mm wide x 1mm thick, was centrally fitted around the edge of the panel leaf on the hanging edge and side edges, and to the upstand of the stop on the closing jamb of the frame.

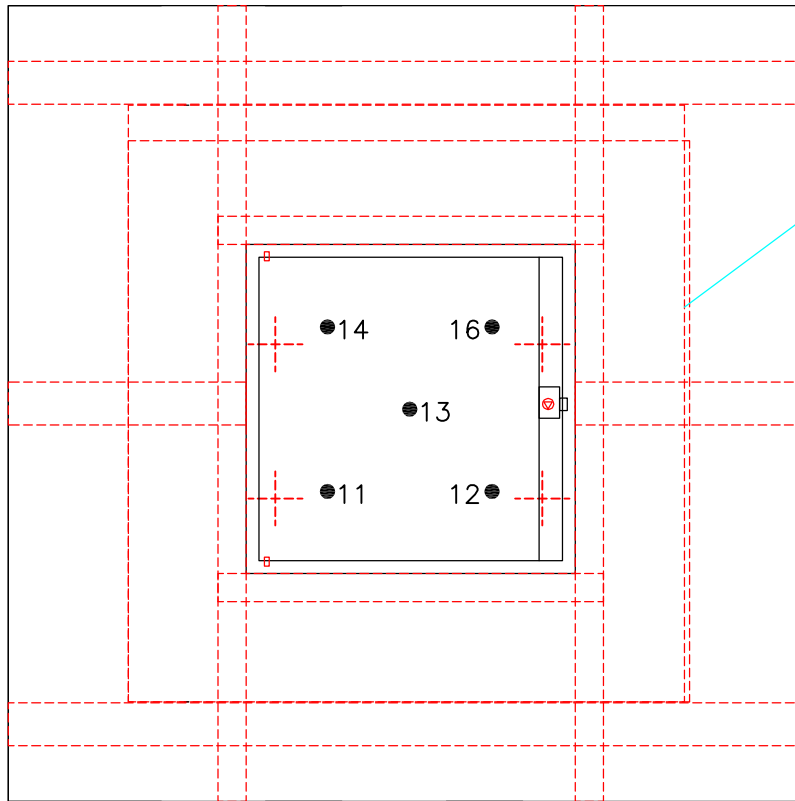
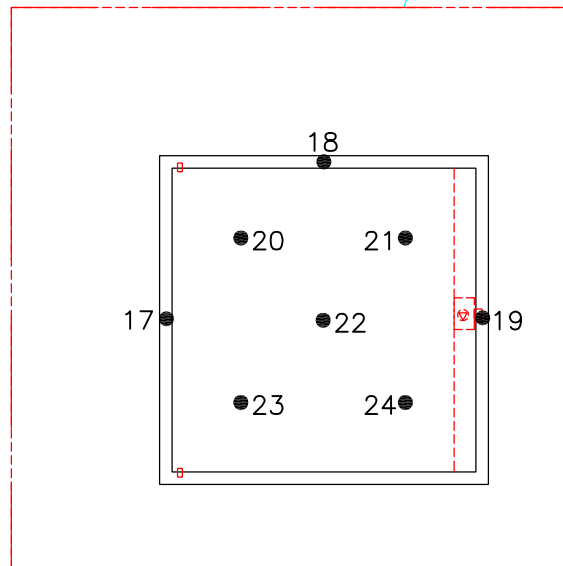
Title
Thermocouple positions

Top of furnace

Front of furnace

⊕ : Furnace Thermocouples

● : Unexposed Face Thermocouples
