**Test report :**

ACR(M)001:2000 test for  
fragility on Naturalight Systems  
Ltd 1200 mm x 1200 mm  
Standard rooflight

Test report number 209 150d

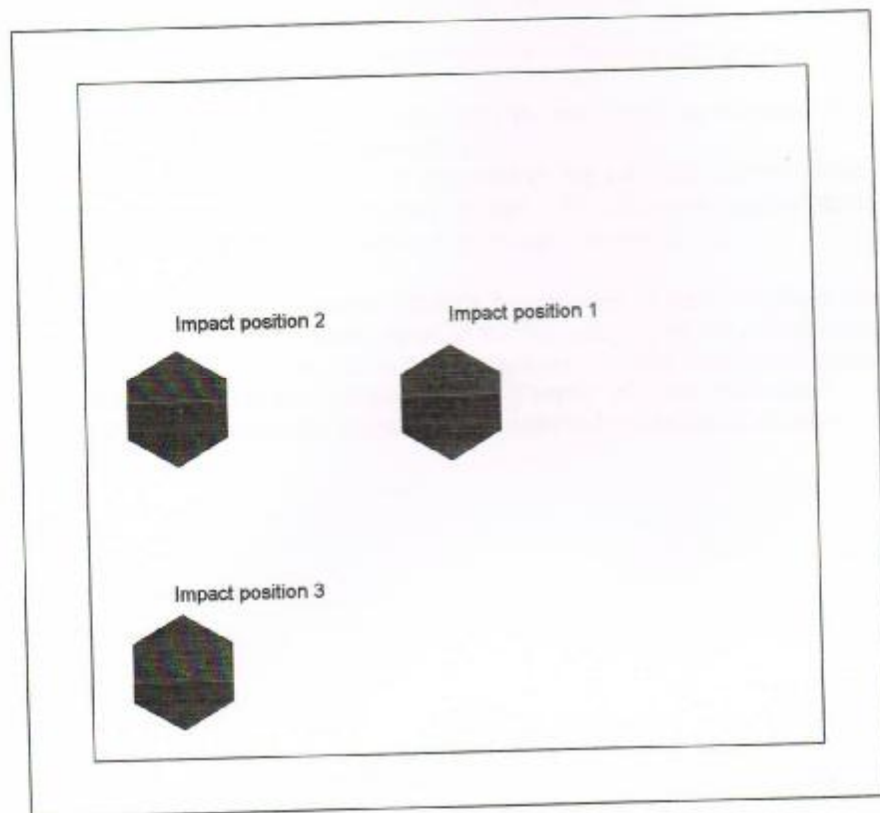
1. Central, at the apex of the glazing.
2. At a point along the longer sides, 300 mm up from the edge of the glazing.
3. Near a corner of the glazing, at a point 300 mm from where it meets the upstand.

Diagram 1. Impact positions on the Naturalight Systems Ltd 1200mm x 1200mm Standard rooflight specimen

The rooflight was impacted at the three positions on the glazing shown in Diagram 1:

The test impacts were performed at three positions on the specimen rooflight shown on diagram 1. The results are given below:

### Position 1. Central, at the apex of the glazing.

**1<sup>st</sup> impact.** The impactor bounced off the rooflight on impact. It was replaced and was then retained at the point of impact for 5 minutes. There was no apparent visible damage to the rooflight.

**2<sup>nd</sup> impact.** The impactor bounced off the rooflight on impact. It was replaced and was then retained at the point of impact for 5 minutes. There was no apparent visible damage to the rooflight.

### Position 2. At a point along the longer sides, 300 mm up from the edge of the glazing.

**1<sup>st</sup> impact.** The impactor bounced off the rooflight on impact. It was replaced and was then retained at the point of impact for 5 minutes. The dome did partially invert on impact but recovered immediately. There was no apparent visible damage to the rooflight.

**2<sup>nd</sup> impact.** The impactor bounced off the rooflight on impact. It was replaced and was then retained at the point of impact for 5 minutes. The dome did partially invert on impact but recovered immediately. There was no apparent visible damage to the rooflight.

### Position 3. Near a corner of the glazing, at a point 300 mm from where it meets the upstand

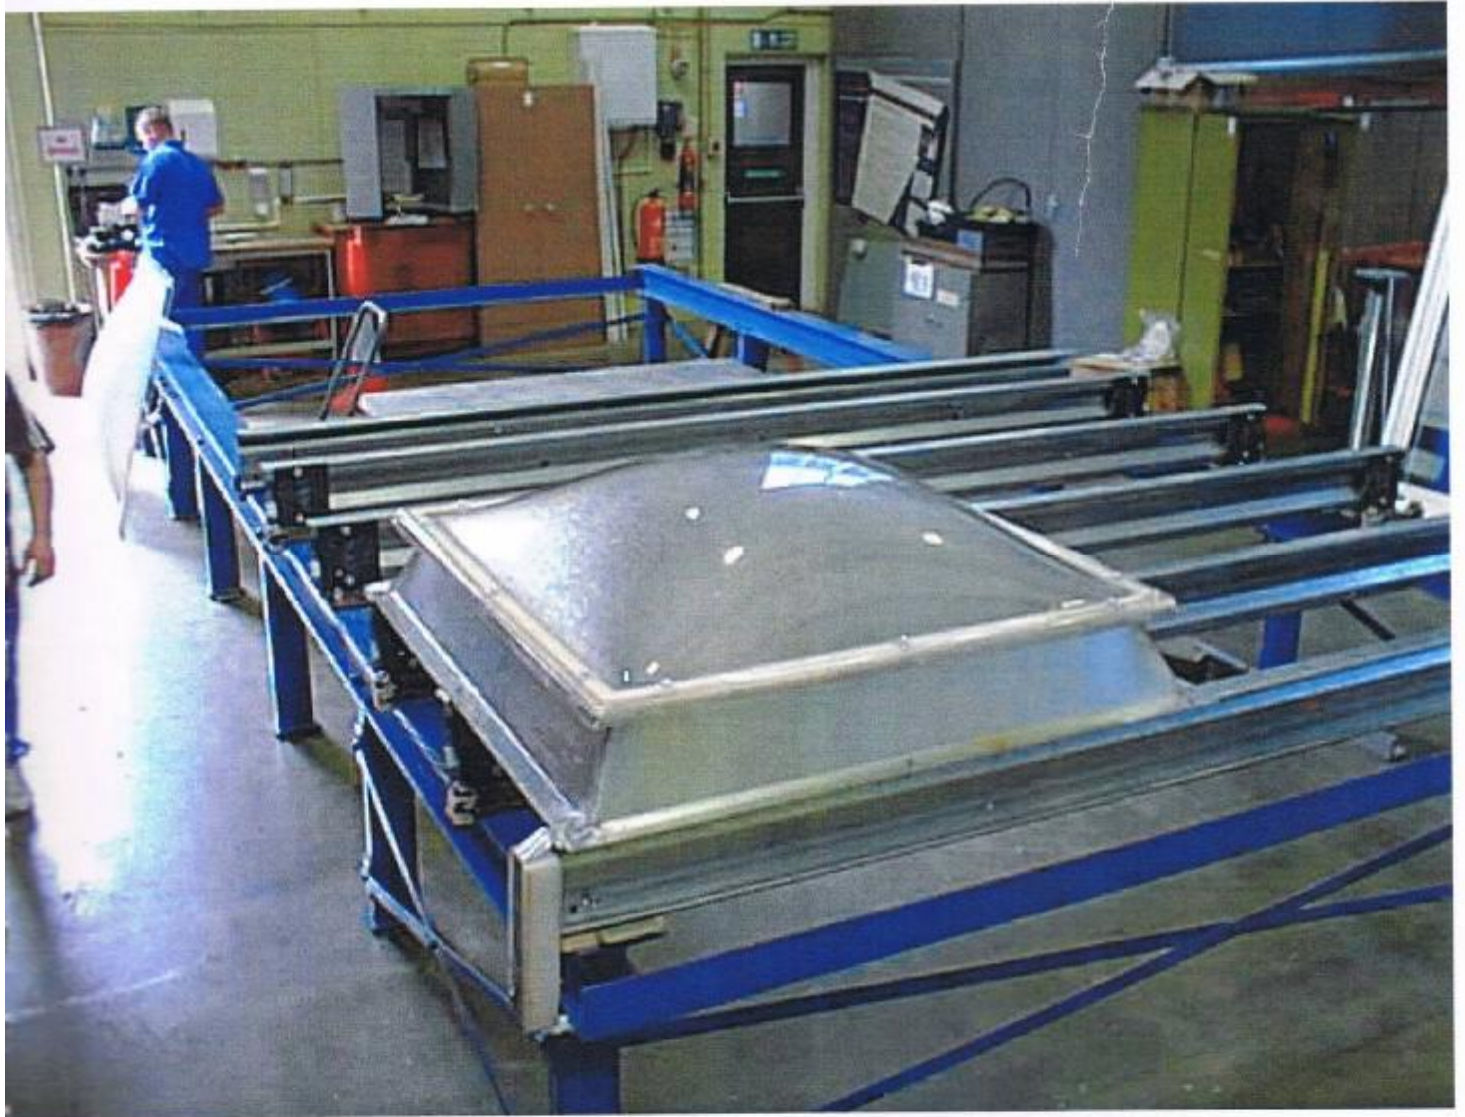
**Figure 1. The 1200mm x 1200mm Naturalight Systems Ltd Standard rooflight mounted on the BRE test rig**

Naturalight Systems Ltd supplied new parts for members of their staff to assemble the rooflight specimen described and tested in this report. The test specimen and components were all stored for at least one hour in the test laboratory conditions before testing. Figure 1 shows the Standard rooflight specimen mounted on the test rig.

**Type:** Square, double polycarbonate skinned domed rooflight, mounted on a galvanised steel upstand. Reference: NaturaLight Systems Ltd Standard rooflight.

**Fixings:** The metal upstand was fixed to the metal purlins at about 600 mm centres using self-drilling/tapping screws. The dome was fixed to the upstand with self-drilling screws with moulded head washers.

**Purlins:** The metal purlins are part of the test rig. They are 3 m long x 0.175 m deep x 0.050 m wide arranged with centres at about 600 mm apart for these tests.

The test rig is that specified in ACR (M) 001: 2000 and consists of a steel frame with steel legs giving a horizontal specimen mounting surface height of about 900 mm. The rig is mounted on a concrete floor. The test specimen is fixed securely to the purlins on this test rig so that it spans across three purlins.

The large, soft body impactor was suspended vertically above the rooflight at an appropriate drop height and released from an electronic release mechanism with a remote trigger. Figure 1 shows the test rig, general test set-up and configuration of the specimen rooflight.
