bre

Testing of Thermohouse Roof Panels

Prepared for: Mr Jack O'Driscoll

Client report number 251-448

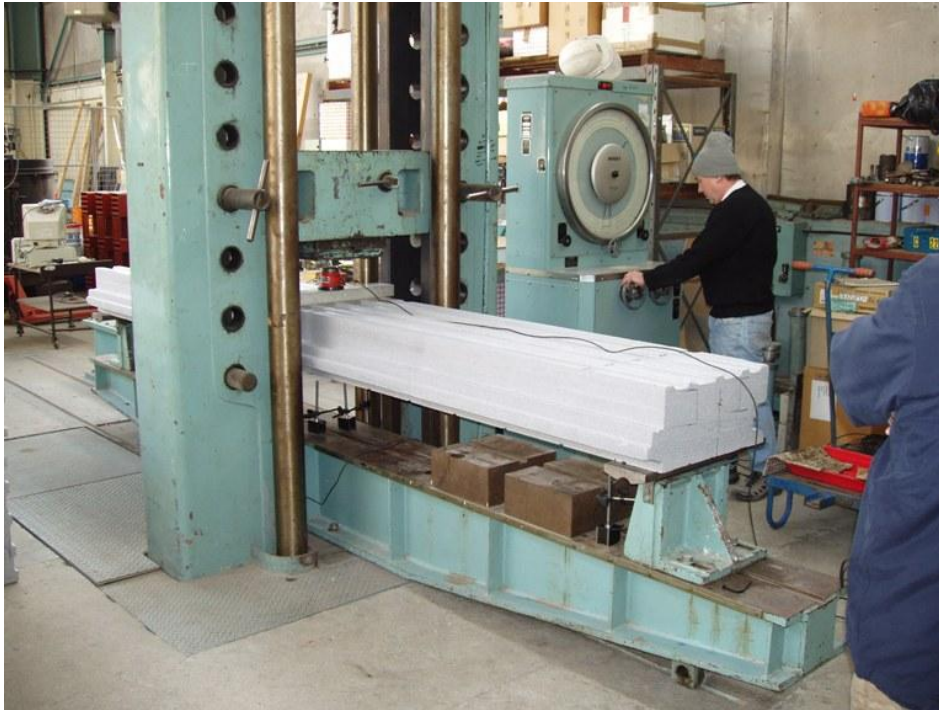
Figure 2. Test set-up.

The test specimens were mounted on rollers giving an effective span of 3.8m. They were loaded centrally in the BRE 250T compression testing machine, via aluminium spreader beams, as shown in the Figure 2.

A load cell was placed at the centre of the spreader beams to measure the load applied to the specimen. The weights of the components of the loading system which rested on the panels in addition to the applied load are given in Table 2.

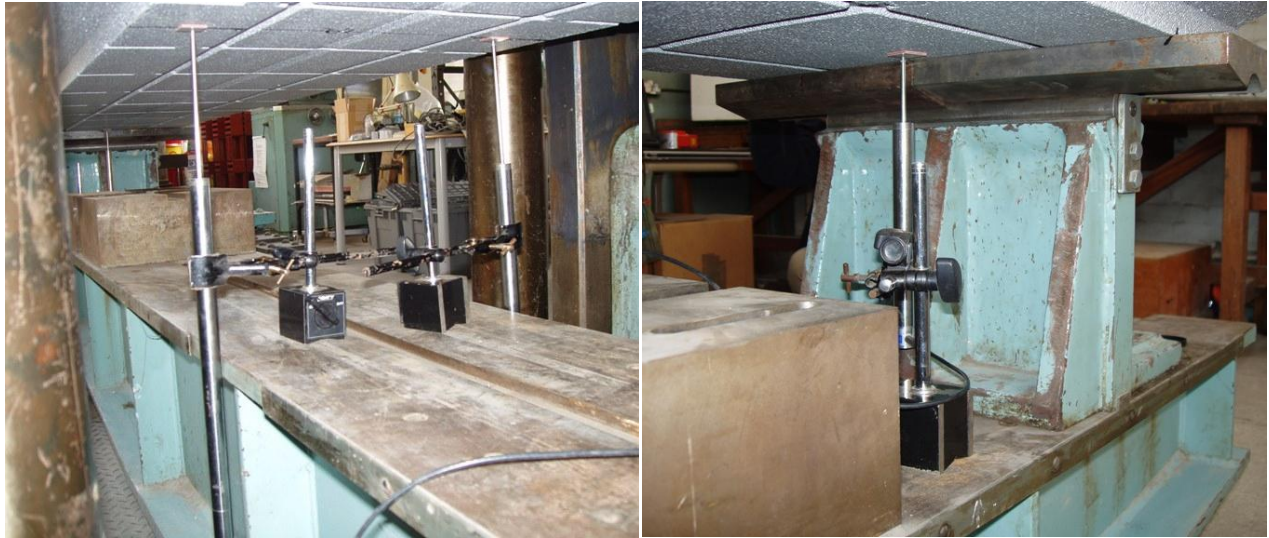
Figure 4. Displacement transducers at mid-span and close to the supports.

The deflection of the panel was measured at mid-span and close to the supports of the panels, as indicated in Figures 3 and 4, using displacement transducers with a resolution of 0.01mm.

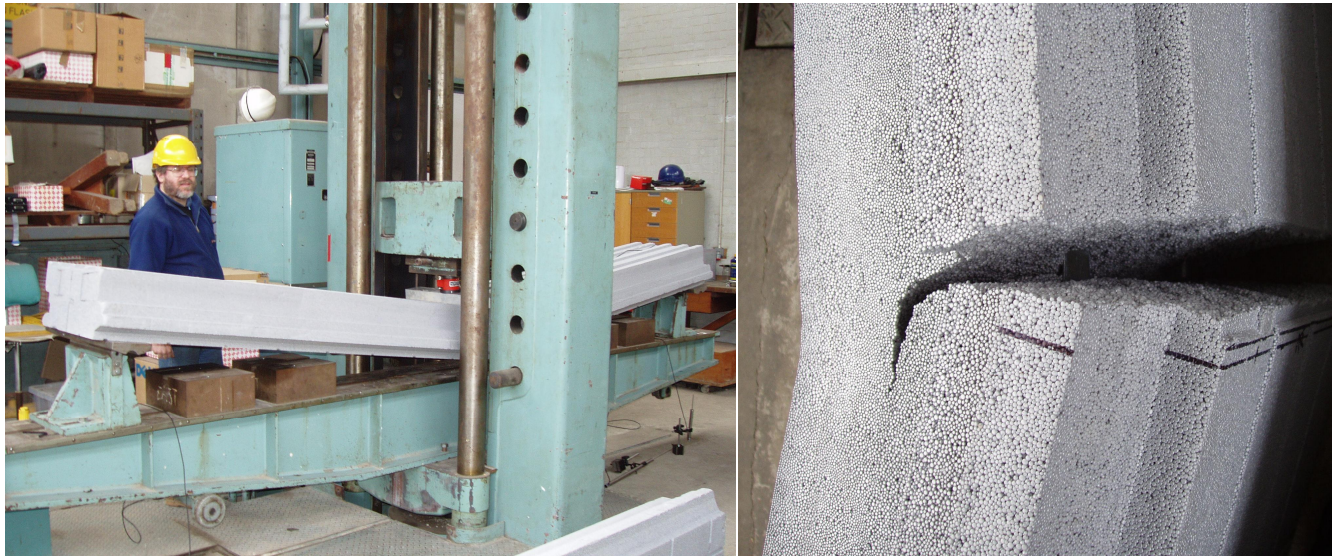
Figure 6. Tensile snap of the polystyrene at the bottom, across the mid-span (Test 1).

Panel number 4 was used for this test. The applied load was increased gradually until the panel failed in flexure. As the load reached about 1.5kN a gap was visible between the steel 'C' profiles and the surrounding polystyrene at the end faces of the panels, which remained without much change throughout the rest of the test. When the load was around 2.4kN a tear in the polystyrene appeared at the top surface of the panel near the aluminium spreader beam as shown in Figure 5. After reaching a maximum load of 3.48kN the load started to drop. With further attempt to apply the load the panel continued to deflect downward, while the actual magnitude of the load decreased, until a sudden tensile snap of the polystyrene occurred at the bottom, across the mid-span of the panel (Figure 6).

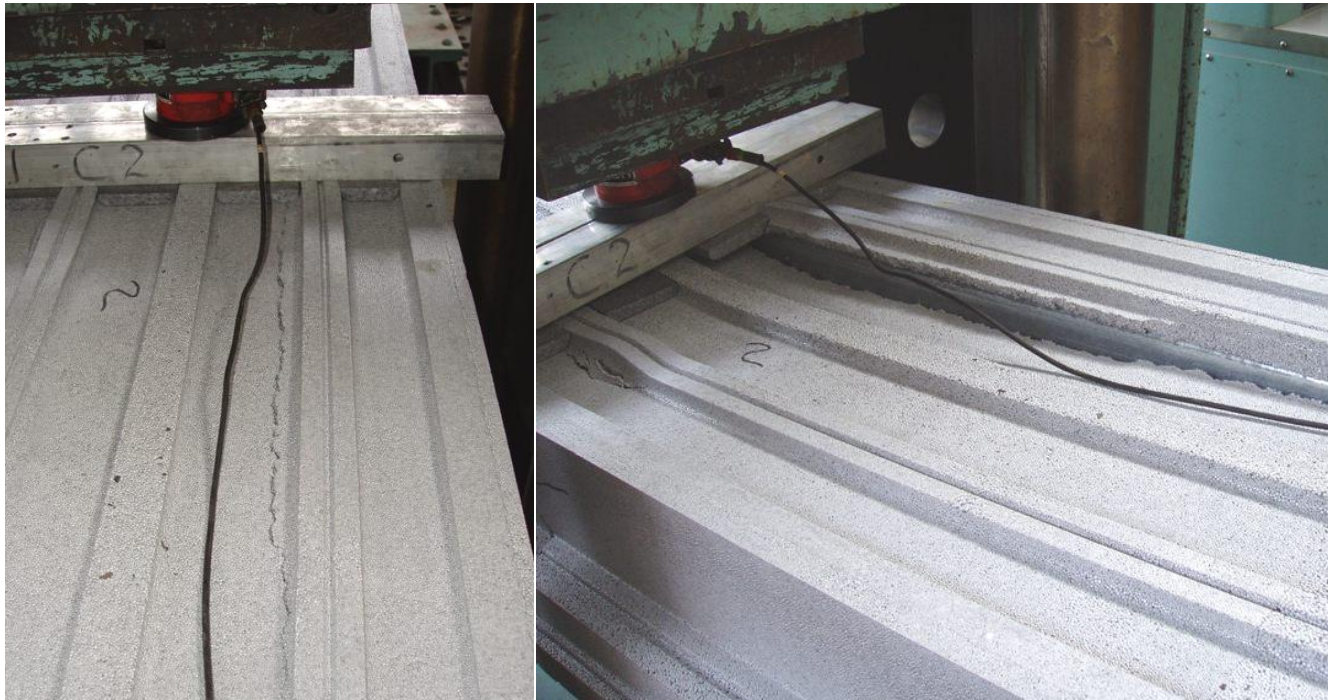
Figure 8. Tearing of polystyrene at the top surface spread along the panel and opened up exposing a steel 'C' profile with increasing deflection (Test 2).

Panel number 2 was used for this test. As the applied load was increased the panel was seen to behave in the same manner as Test 1. However, the tearing in the polystyrene at the top surface of the panel (near the aluminium spreader beam) was seen to spread along the panel with increasing load, as shown in Figure 8. The load started to drop after reaching 3.61kN and as the downward deflection in the panel increased the tearing in polystyrene at the top of the panel opened up exposing a steel 'C' profile (Figure 8). The loading was stopped as the polystyrene at the bottom, close to the mid-span, snapped in tension as seen in Test 1. The exposed steel 'C' profile, however, was observed to have bent about 400mm away from the mid-span of the panel (Figure 9). (The other steel 'C' profile had bent close to the mid-span of the panel.)

This unsymmetrical bending in the steel 'C' profiles seemed to be the cause for the tearing up of polystyrene seen in Figure 8.

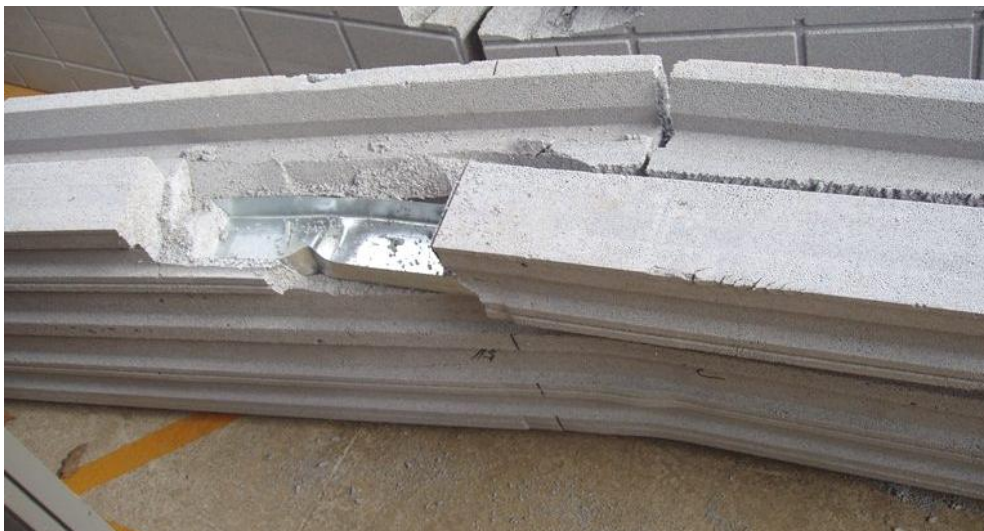
Figure 9. The exposed steel 'C' profile was observed to have bent about 400mm away from the mid-span (Test 2).

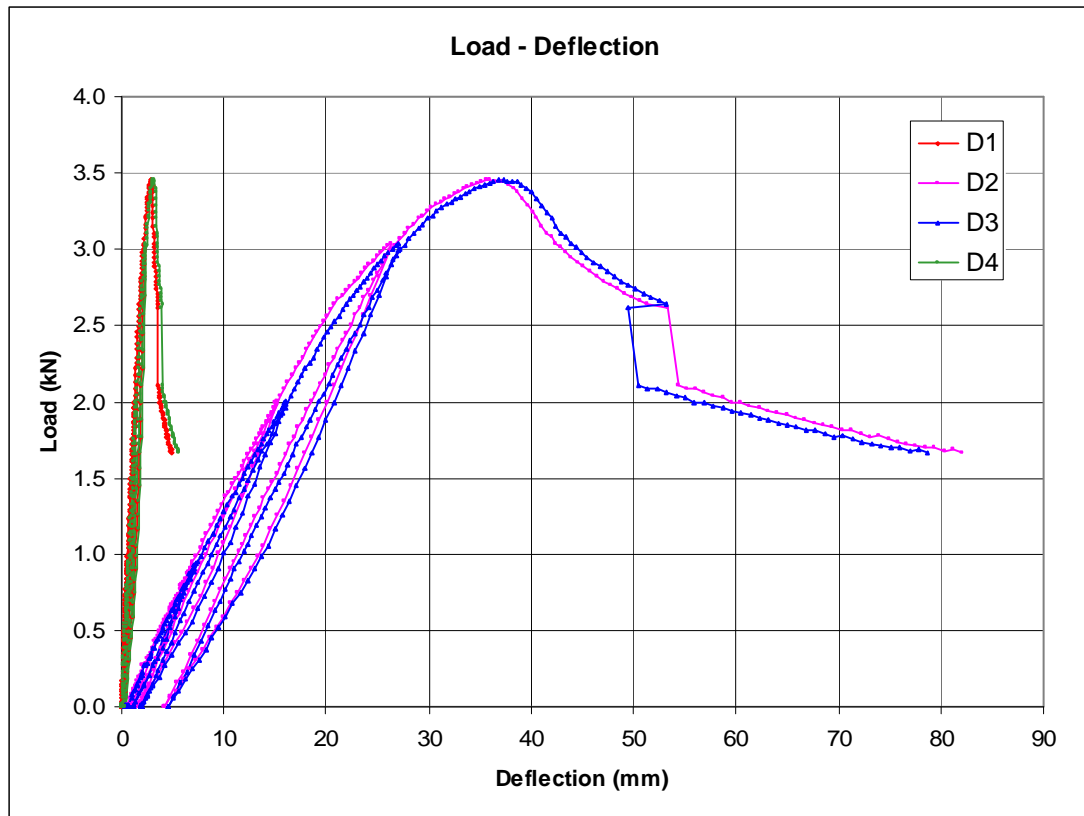
Figure 12. Load-deflection curve for Test 4. (Note – to prevent damage to the displacement transducers at mid-span, they were removed once the panel deflection was in excess of 75mm.)

The load-deflection curve for this test is given in Figure 12. (Note – to prevent damage to the displacement transducers at mid-span, they were removed once the panel deflection was in excess of 75mm.)

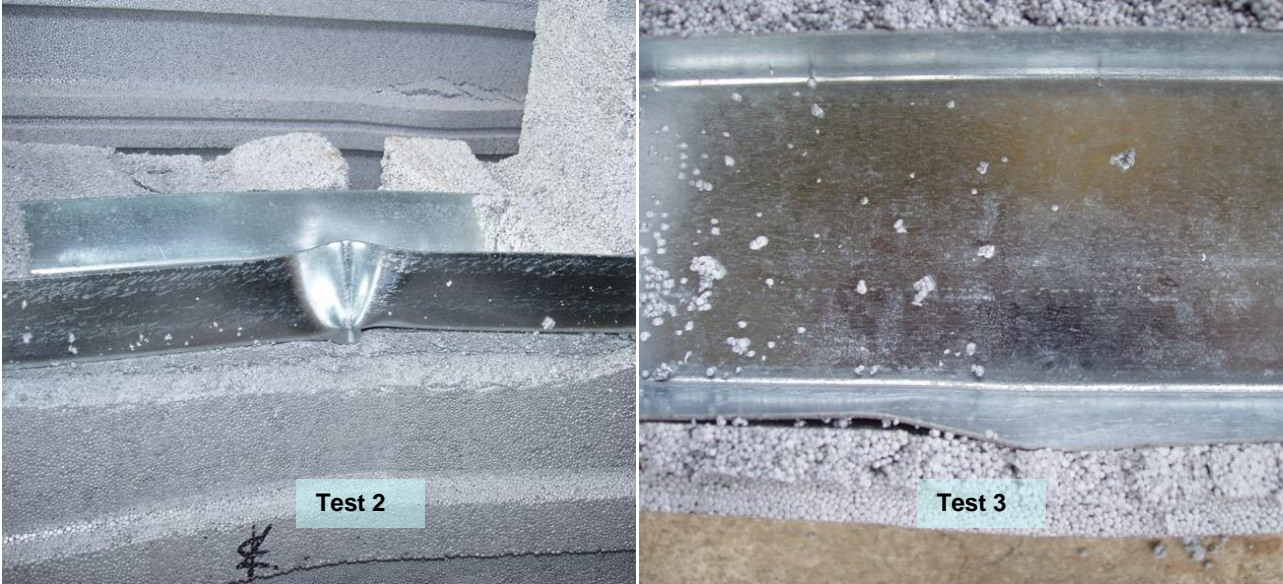
Figure 13. Buckling in the compression flange of steel 'C' profiles.

The removal of the polystyrene surrounding the steel 'C' profiles at the end of the Tests 1, 2 and 3 revealed buckling in the compression flange (see Figure 13). No signs of torsional rotation of the steel 'C' profiles were noticed in these inspections.

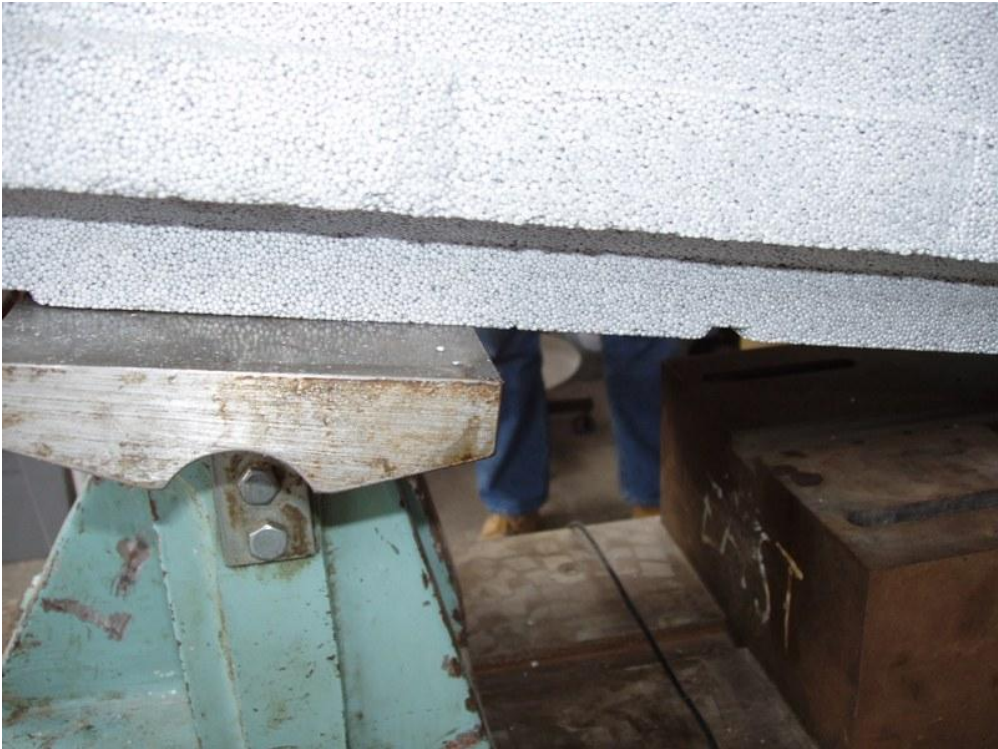
Figure 14. Compression in polystyrene at the supports was observed to be very small.

While the compression in polystyrene at the supports was difficult to measure, it was observed to be in the sub-millimetre range (see Figure 14).

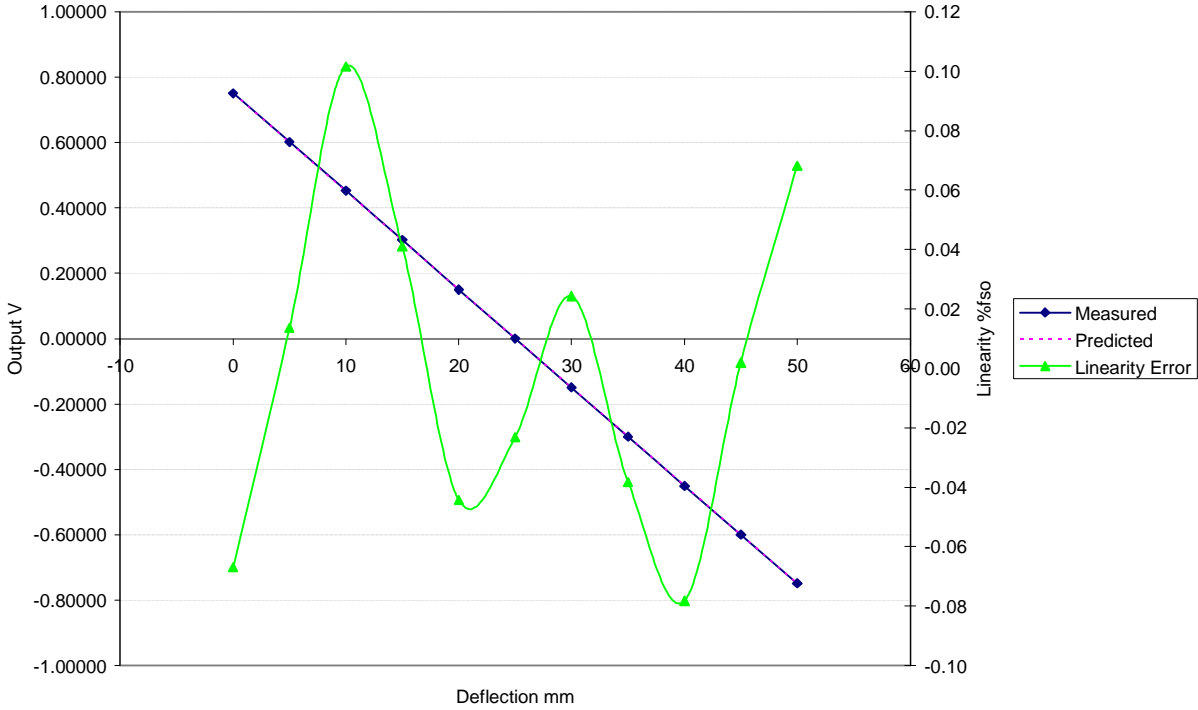
LVDT for displacement D3

Title: RDP Electronics LVDT
 Type: LDC3000A
 Ser No: 747
 Location: B14/B01 Operator: D Brooke
 Date of Test: January 29, 2009

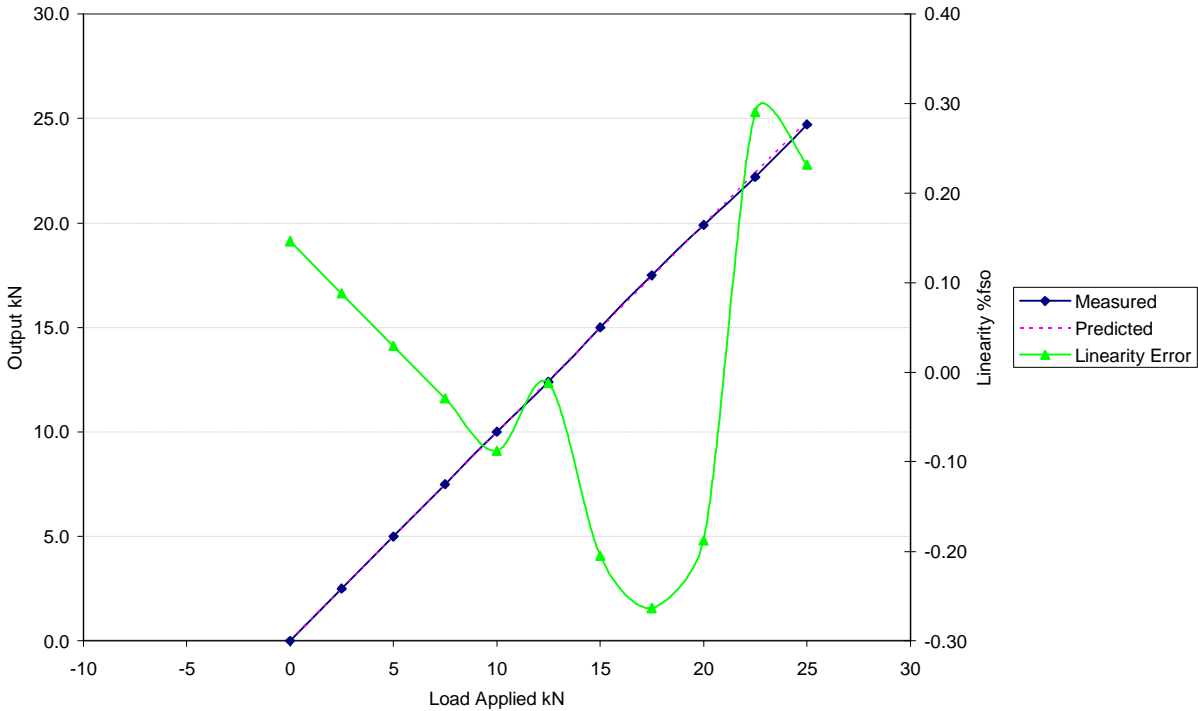
Load cell

Title: Novatech Load Cell and BRE Readout

Type: 100kN
