## **IFC ENGINEERING ASSESSMENT REPORT**

# **Engineering Assessment of Biotechture Living Wall System With Respect to Reaction to Fire Classification**

**Reaction to Fire Classification Standard: BS EN 13501-1:2007 +A1:2009**

**IFC Report PAR/16691/01**

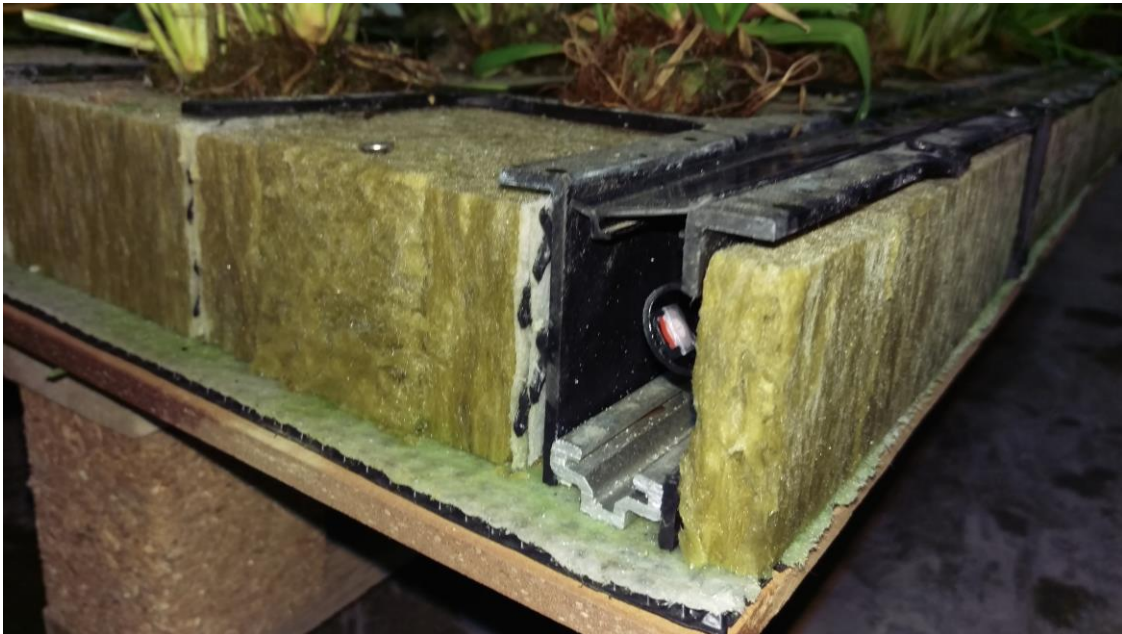
- The Biotiles are secured to a backing board constructed from nominally 8mm thick Rockpanel 'Durable' with a nominal density of 1050±150Kg/m<sup>3</sup>.

- The irrigation system between the Biotiles is created from a drip line by DuraDrip, and is made from polyethylene with the cover strip made from PVC. The drip line is held in place using an aluminium profile screw fixed to the Rockpanel backing board.

**Photo 1 – Cross sections of Biotiles including irrigation system, backing board and Terram drainage layer.**

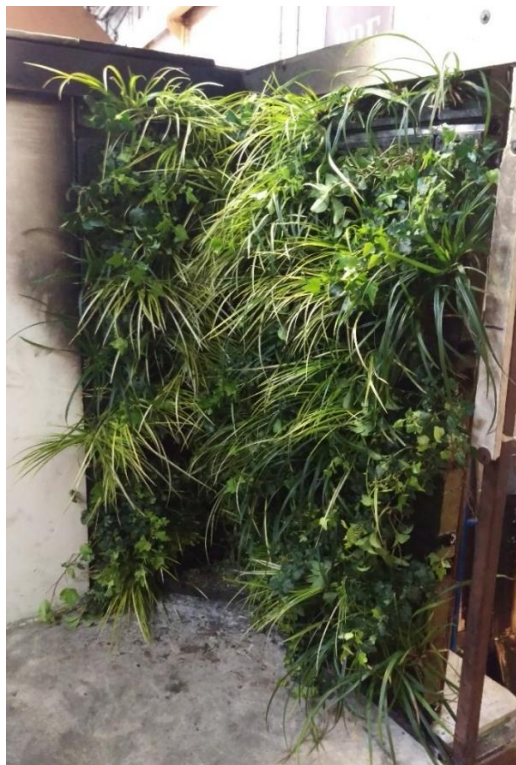
**Photo 2 – Living Wall System before test 1 of BIO-FT-001  
– Note the planted material cut back at flame impingement area.**

In the first test of BIO-FT-001, the plant material was only cut back at the area of the flame impingement zone. This therefore meant that the maximum mass of planted material remained on the specimen, and enabled the maximum potential smoke/steam production as the plants burnt, and also more likelihood of flaming droplets as burning plant material fell to the floor of the test apparatus. Smoke production (s) and burning droplet (d) results as close to the end use application were therefore able to be generated. **s3** & **d2** were the results that were achieved from this test.

It was noted in this test, that the shrouding of the flame impingement zone, by the plant material (see photo 2), caused the flame from the test apparatus to burn inefficiently. A positive characteristic for the end use, as fire propagation would likely be inhibited, but this potentially caused the test to be less onerous other than in relation to the smoke production (s) and the flaming droplet (d) result.

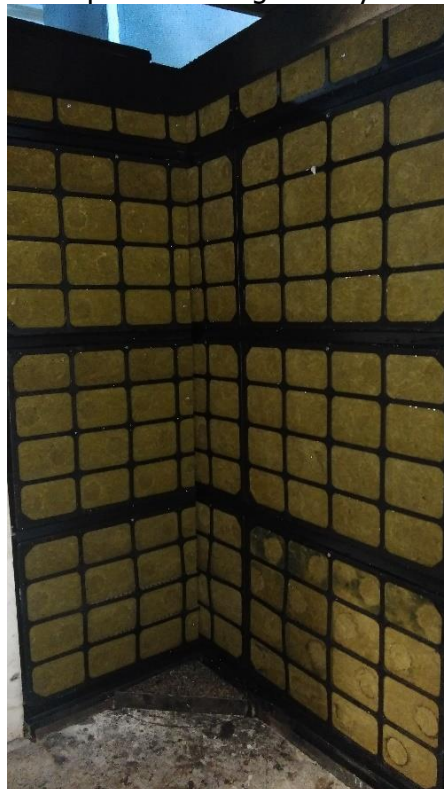
**Photo 3 – Unplanted Wall System before test 1 of BIO-STD**

It was therefore decided, that for more comprehensive results, three further tests would be conducted on an unplanted, but saturated Living Wall System as noted in section 3.3.2. This meant that 3 sets of results with the required flame efficiency from the test apparatus would be achieved, as the test specimen would be a more uniform flat surface (see photo 3), and therefore in accordance with the test standard EN 13823:2010. Due to the saturation of the Biotiles, in order to provide a more realistic end-use state, conditioning was again not possible and therefore the testing was conducted on an ad-hoc basis.

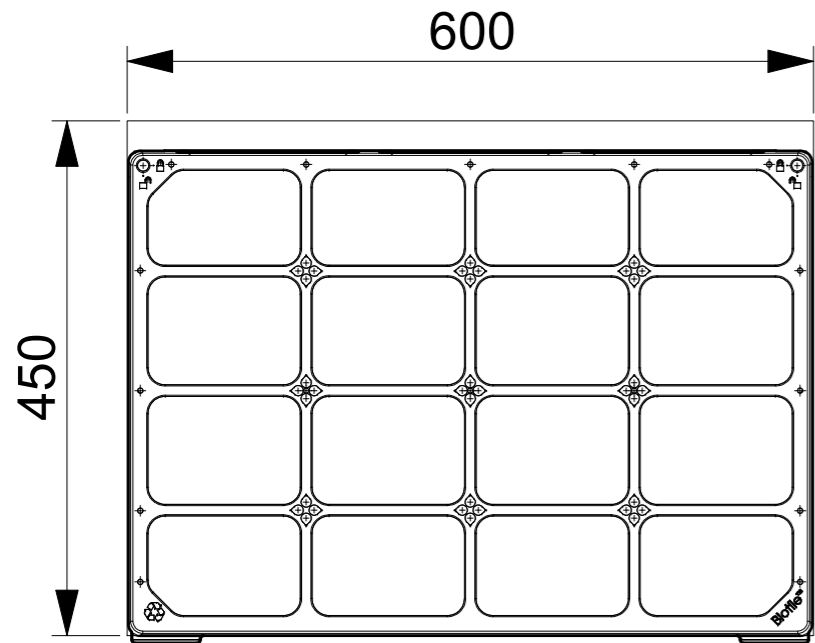
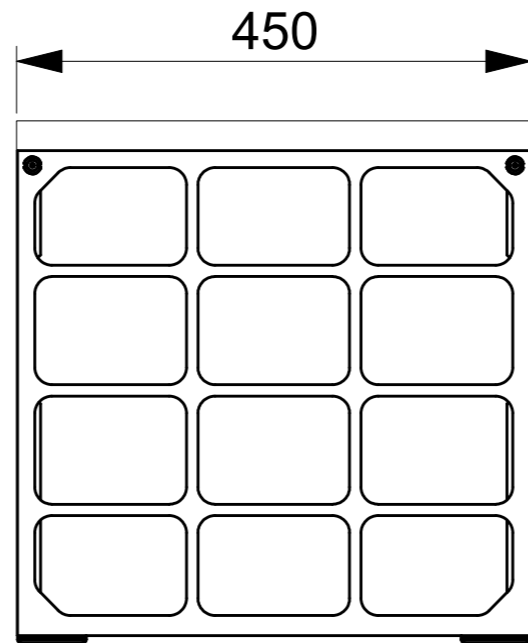
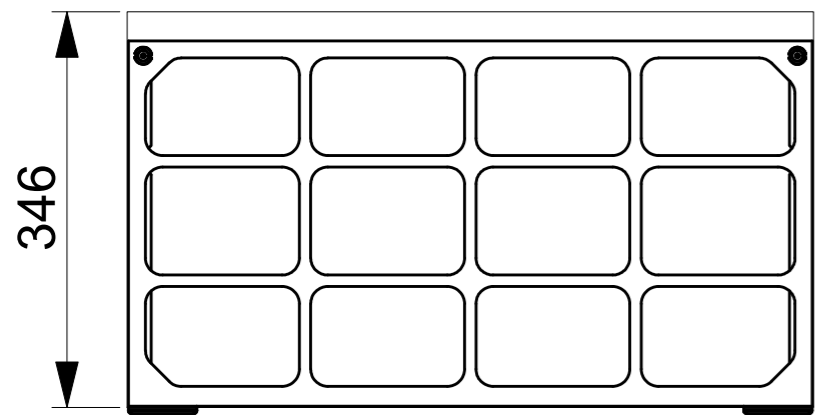
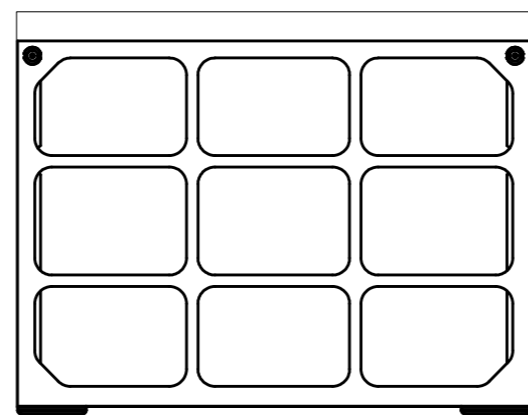
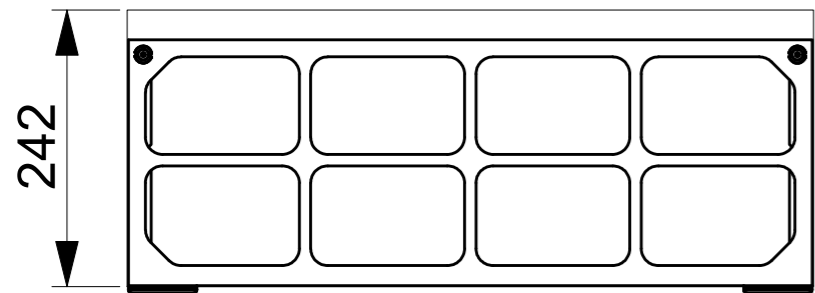
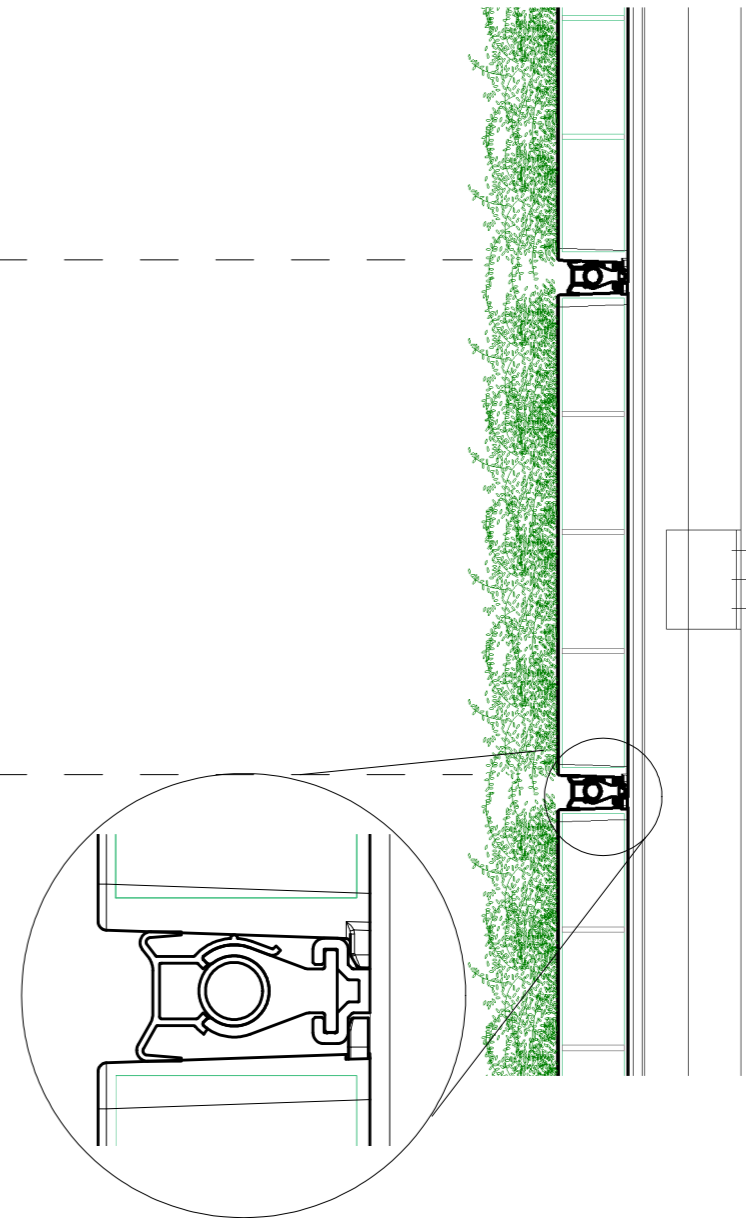
Date: 21/04/15  
 Drawn: SB  
 Checked:  
 Drawing No: BIO-PL-01  
 Revision: A

Client: BIOTECTURE  
 Project: BIOTILE STANDARD PANEL SIZES  
 Title: BIOTILE STANDARD PANEL SIZES

**'Biotile Standard Panel Sizes' Rev A, 'Irrigation Layout Schematic' xxxx-IS-001 and 'Standard Section' dated 15/04/15**

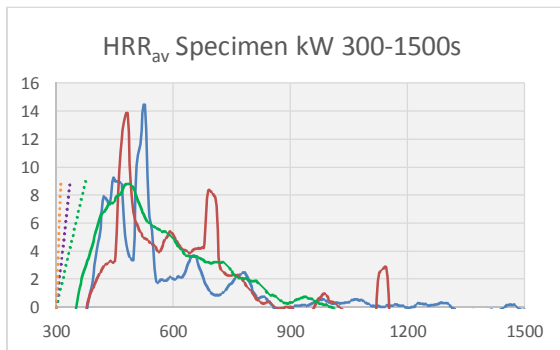
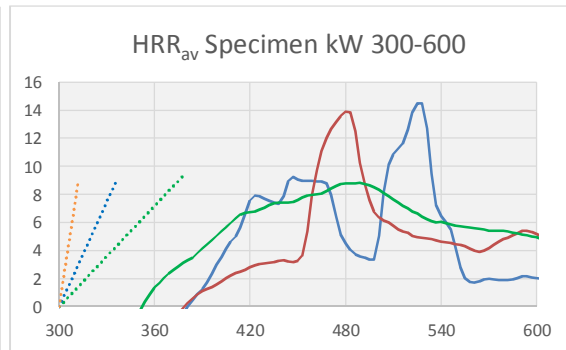
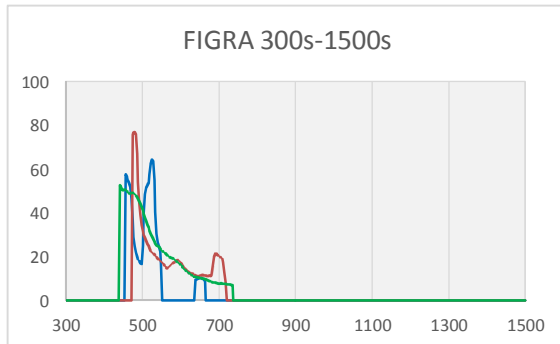
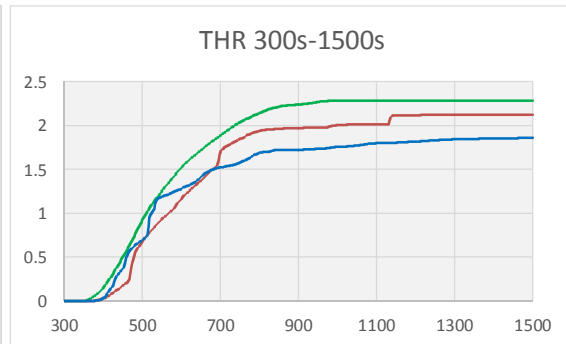
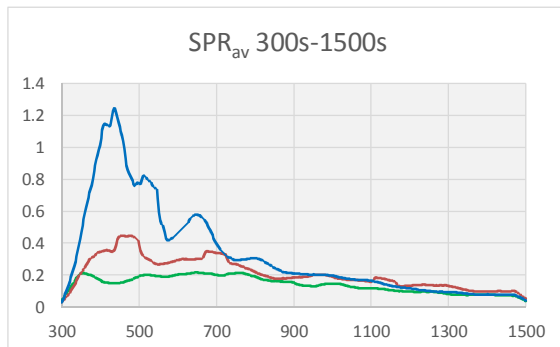
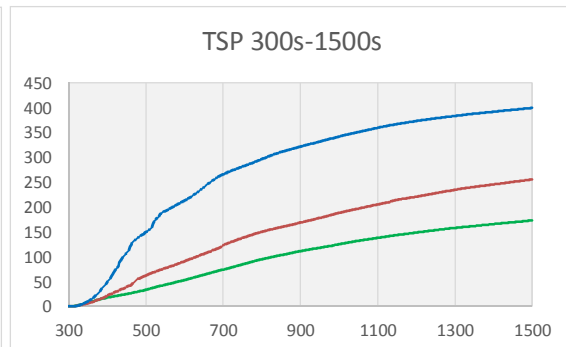
### Test Averages

THR <sub>600</sub>	1.98
FIGRA <sub>0.2MJ</sub>	66.29
FIGRA <sub>0.4MJ</sub>	64.64
TSP <sub>600</sub>	199.85
SMOGRA	63.59
LFSedge {Y/N}	N

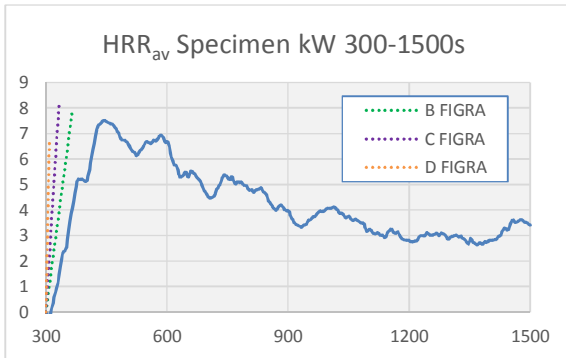
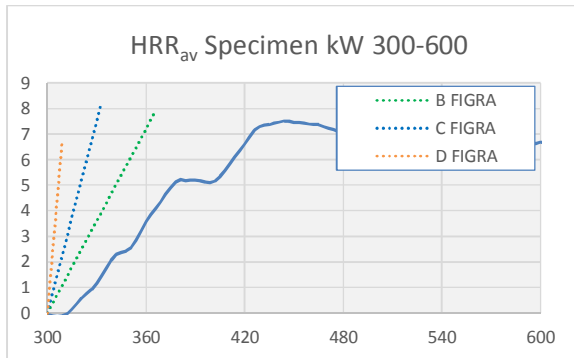
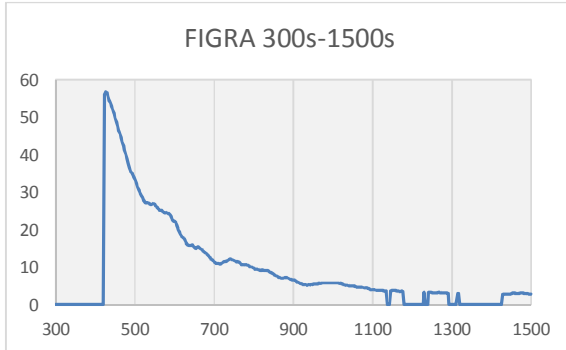
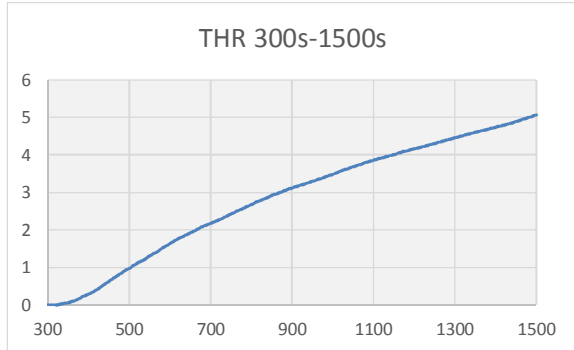
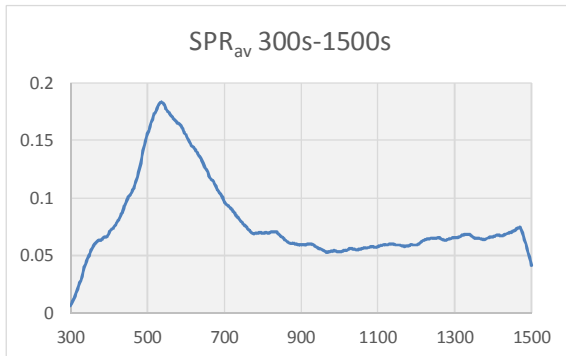
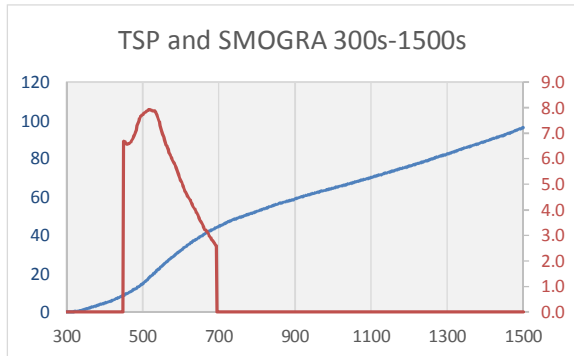
**Comments**

LFSege {Y/N}: No  
 FDP (f <= 10s) {Y/N}: No  
 FDP (f > 10s) {Y/N}: No  
 Full test duration/performed {Y/N}: Yes  
 Smoke Correction Used: No

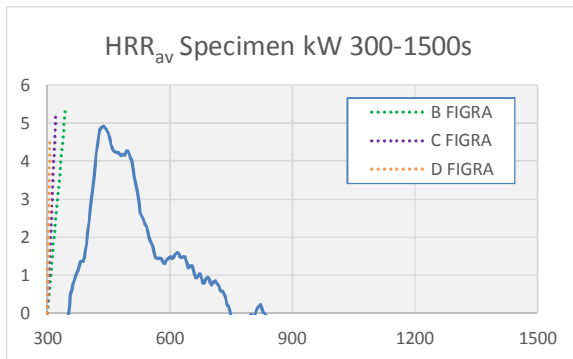
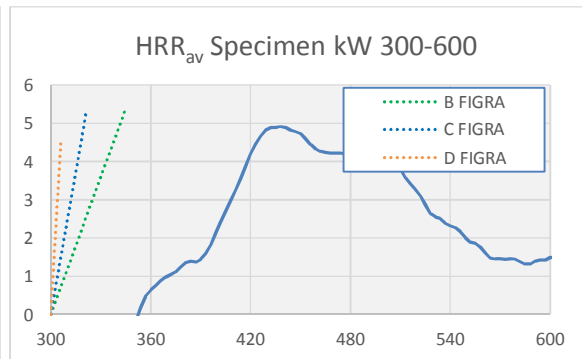
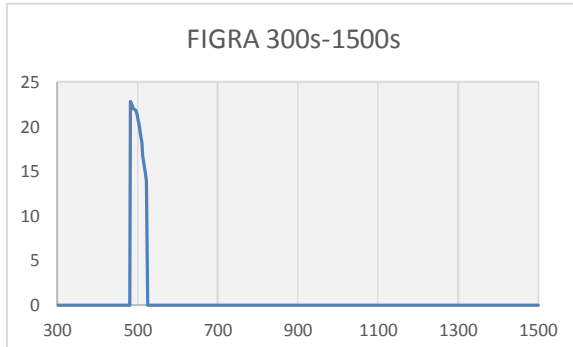
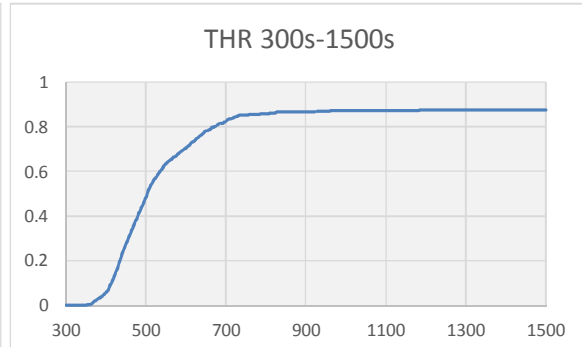
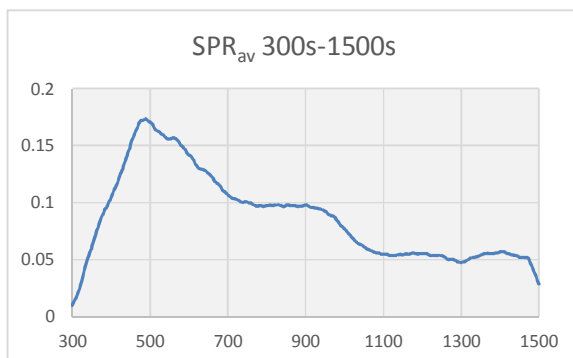
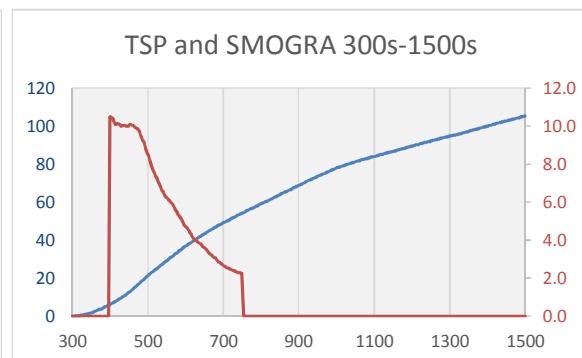
**Comments**

LFSedge {Y/N}: No  
 FDP (f <= 10s) {Y/N}: No  
 FDP (f > 10s) {Y/N}: No  
 Full test duration/performed {Y/N}: Yes  
 Smoke Correction Used: No

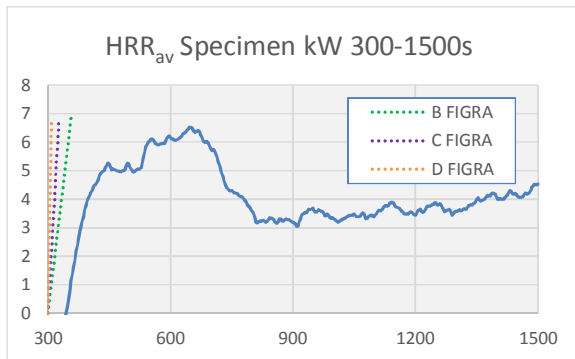
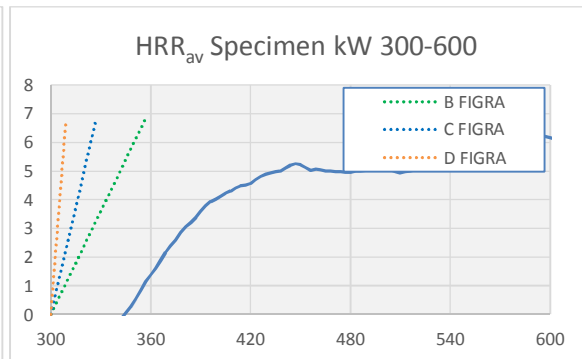
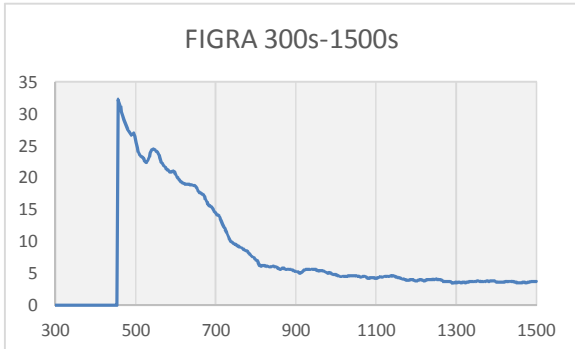
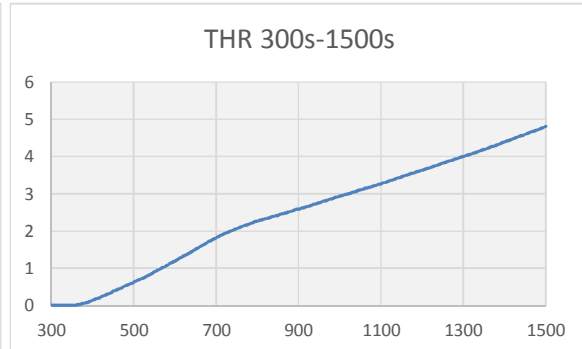
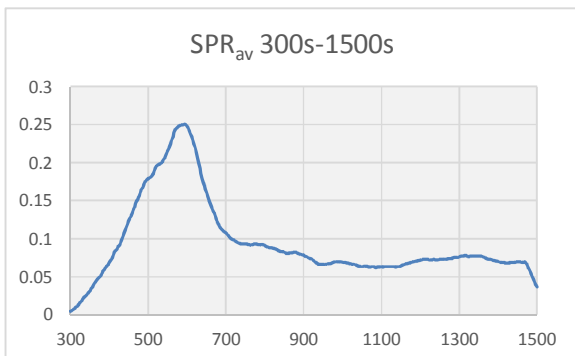
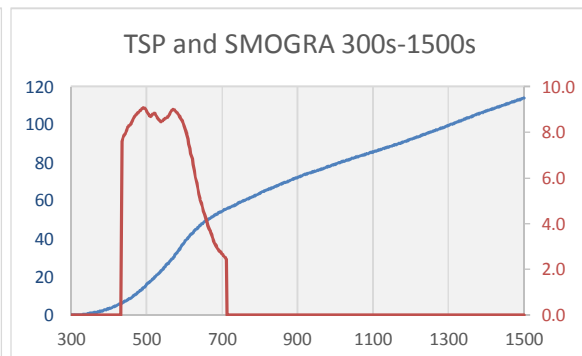
**Comments**

LFSedge {Y/N}: No  
 FDP (f <= 10s) {Y/N}: No  
 FDP (f > 10s) {Y/N}: No  
 Full test duration/performed {Y/N}: Yes  
 Smoke Correction Used: No

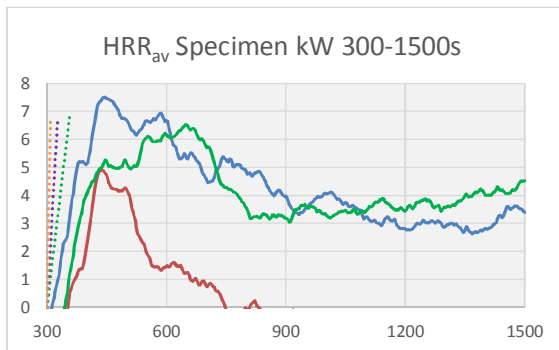
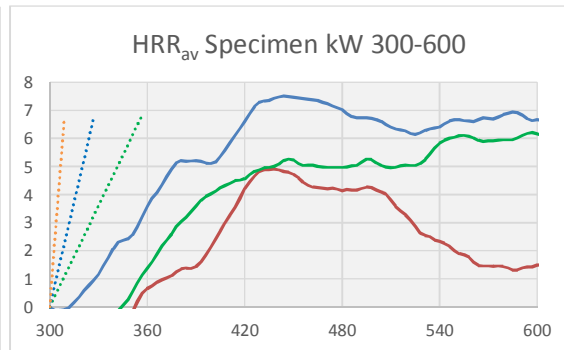
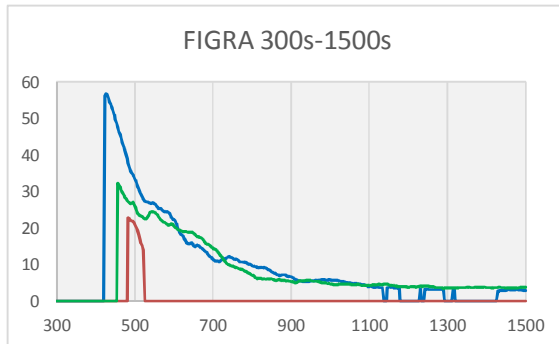
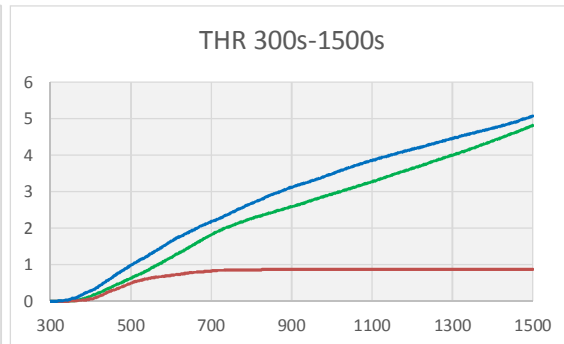
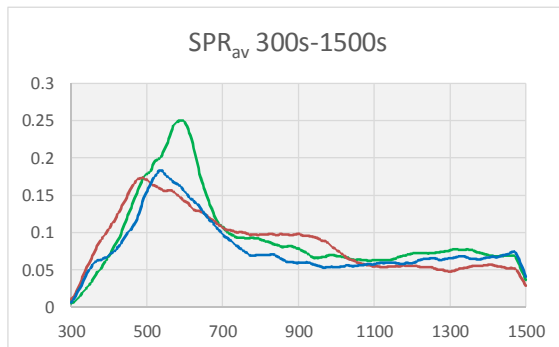
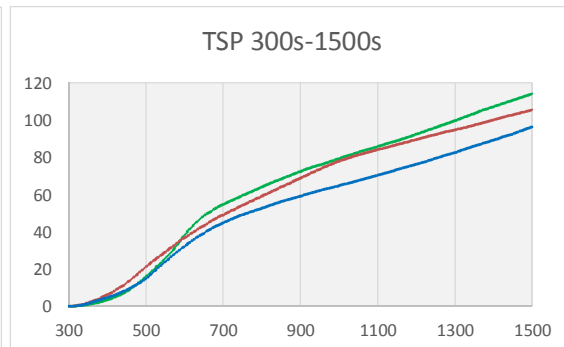
### Test Averages

THR <sub>600</sub>	2.19
FIGRA <sub>0.2MJ</sub>	45.31
FIGRA <sub>0.4MJ</sub>	37.27
TSP <sub>600</sub>	66.66
SMOGRA	9.16
LFSedge {Y/N}	N
