CM100 WATERPROOFING - HIGH BUILD SYSTEM

SYSTEM DETAIL

INSULATED PLAZA DECK with PAVERS

CM-HB02

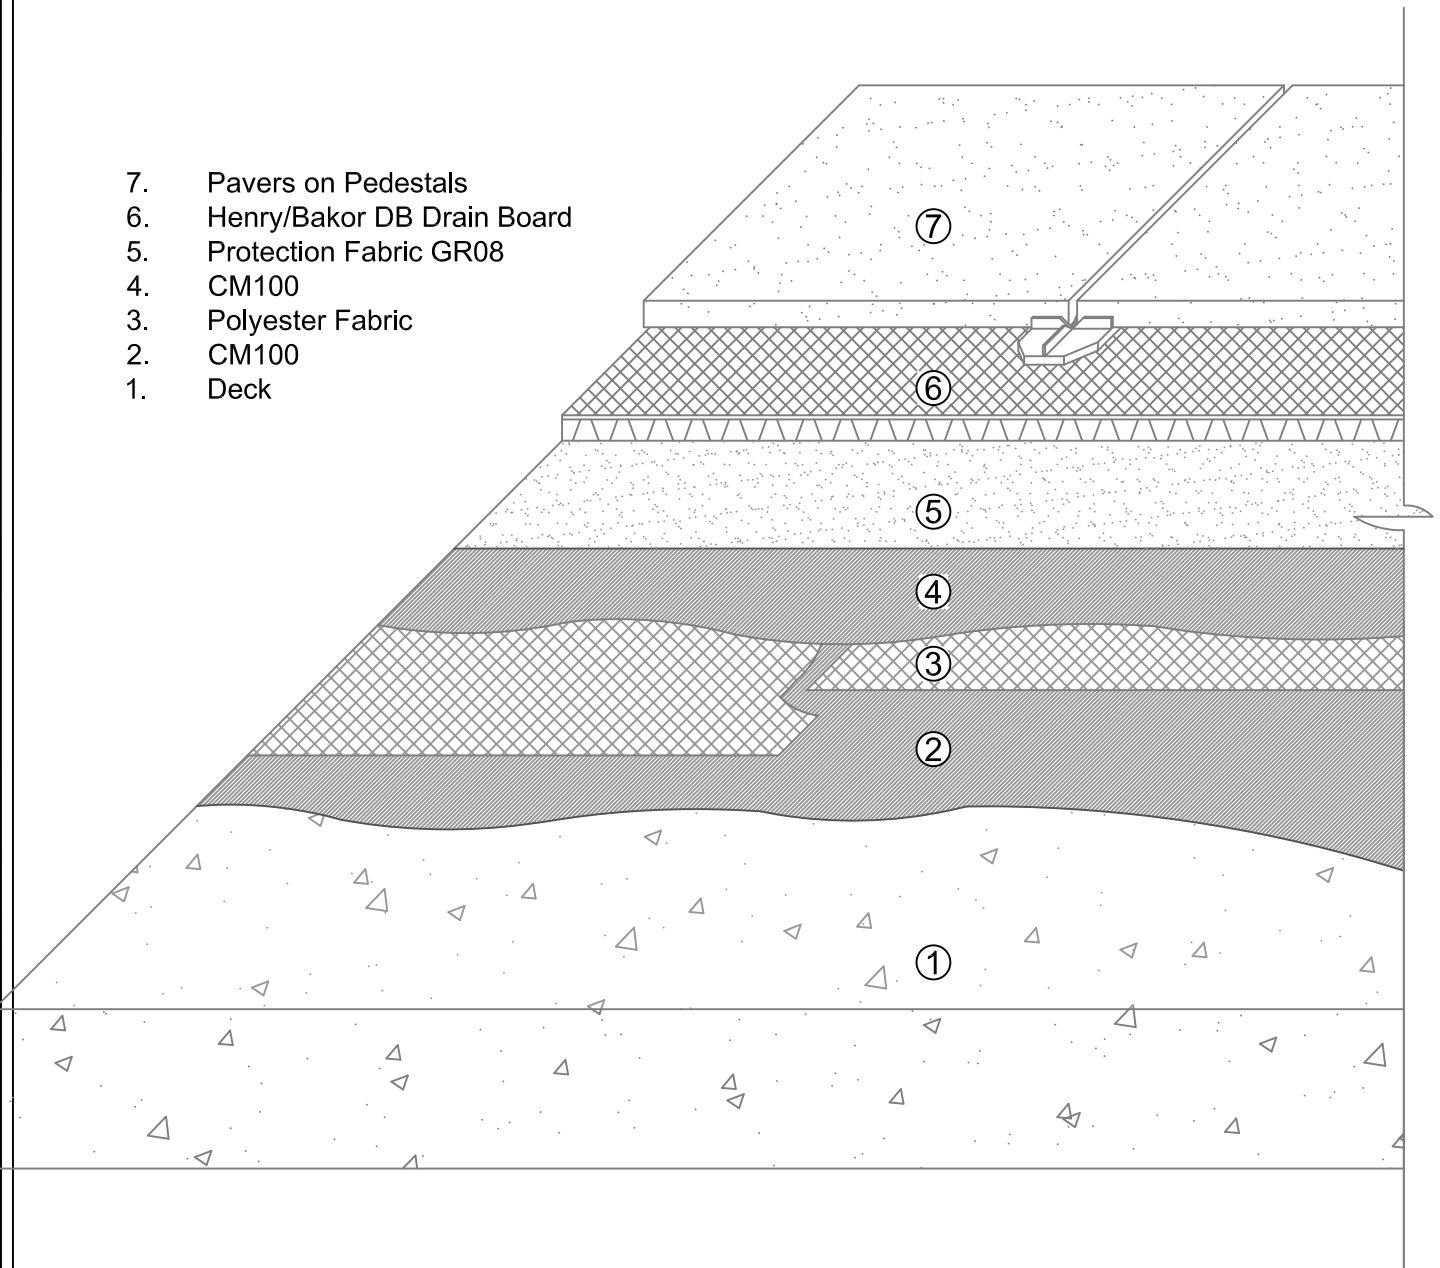
- 7. Pavers on Pedestals
- 6. Henry/Bakor DB Drain Board
- 5. Protection Fabric GR08
- 4. CM100
- 3. Polyester Fabric
- 2. CM100
- 1. Deck

- 1. Detail showing CM100, a two ply reinforced, cold-applied, fast curing waterproofing membrane system incorporating insulation and pavers.
