Surface Protection - Product Code: Stainless Steel Waste Bins KWB900

Product Specification:

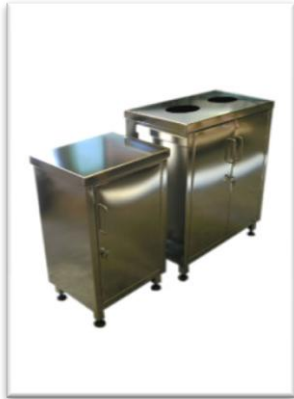
- Suitable for cleanroom, sterile rooms, food processing and research areas
- No dirt traps
- Doors are fitted with budget locks or ball locks
- Left or right hand hinges available
- Unique fully concealed hinge system
- Various handles available including D handles and spring loaded recessed handles.

The Kent Stainless waste bins are designed for use in gowning/changing rooms where it is imperative no contained operators or equipment enter the cleanroom area.

The freestanding waste bins ensure operators have a clean, low maintenance unit in which to discard unwanted garments and / or waste. Available in single or double units.

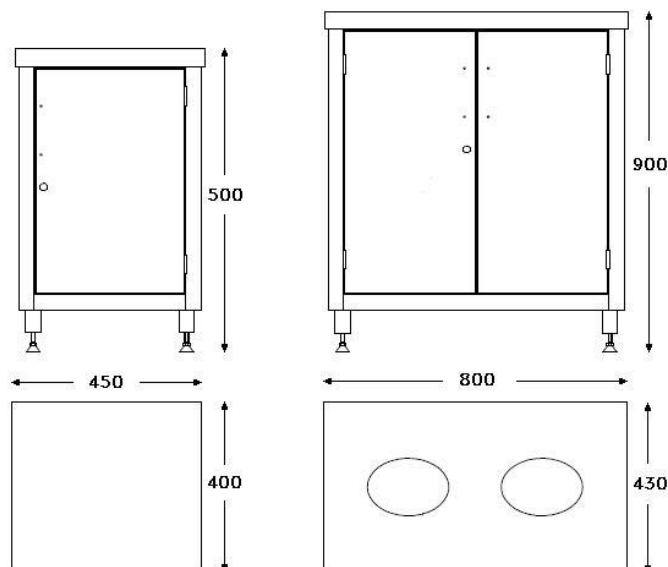
Product Dimensions:

Reference	Height	Width	Depth
KWB900	900mm	800mm	430mm
KWB500	500mm	400mm	450mm
