Greenfields
Maidenhead, Berkshire

Sector: Social Housing
Medium Rise
Refurbishment

Product:
External Wall Insulation &
Render Finish

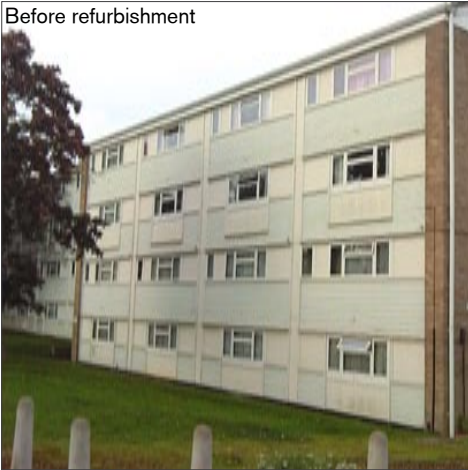
Before refurbishment

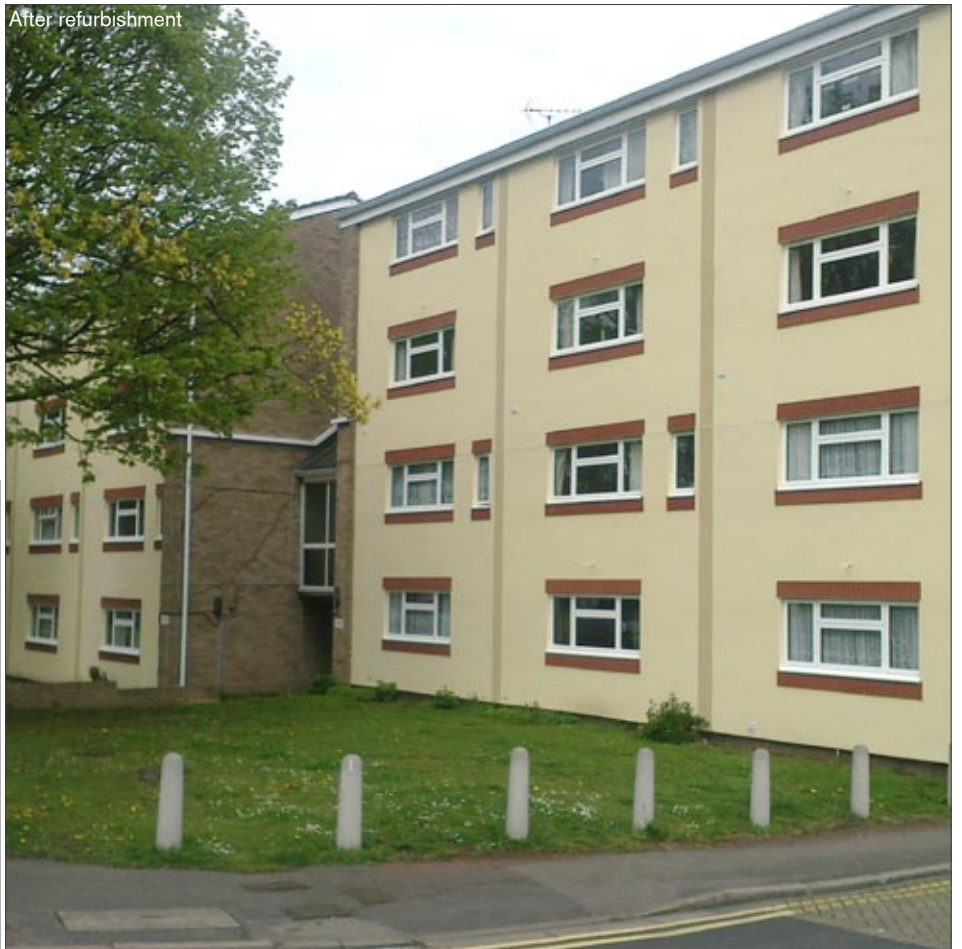
After refurbishment

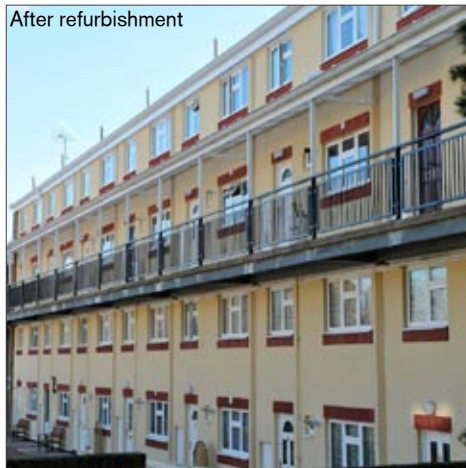
After refurbishment
