**Structherm | Cladding**

**Bucknall Crescent**  
Bartley Green, Birmingham

**Sector:** Social Housing  
Medium Rise Flats  
Refurbishment

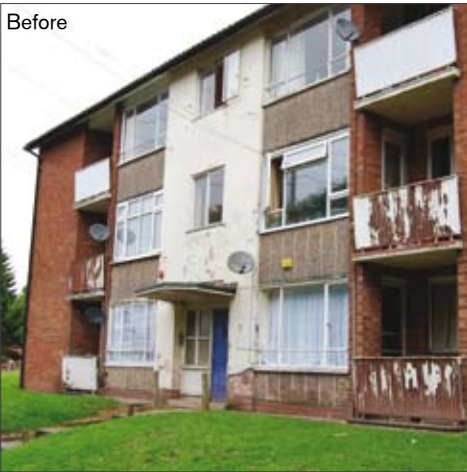
Before

These flats, in a three storey block in Bartley Green, were built using a combination of brick and concrete panels. The flats urgently required external refurbishment due to the failure of wall ties and problems with damp, condensation, water ingress and poor thermal performance. The flats were also looking dilapidated and in a bad state of repair in particular the balcony balustrades which were badly rusted.

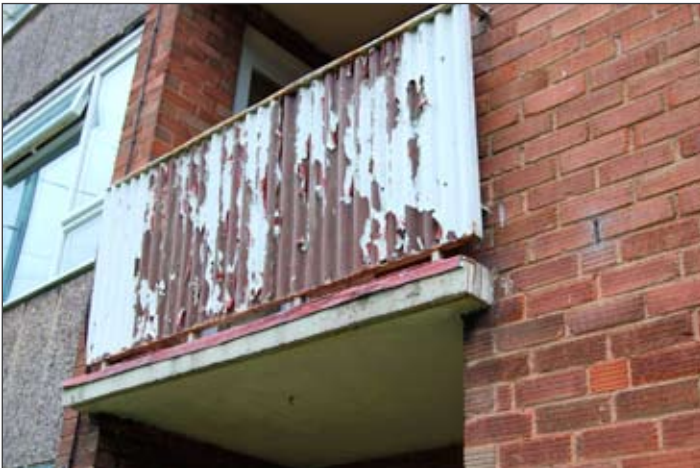
The balconies prior to refurbishment were an eyesore with badly rusted balustrades.

To complete the system a traditional Macerend brick effect render finish was applied to the ground floor along with a striking combination of FlessCoat Cortina Normale TH acrylic render in orange and white to the other floors. In addition metal chequer plate was installed under the windows where the balconies were to give the block a fresh modern appearance.

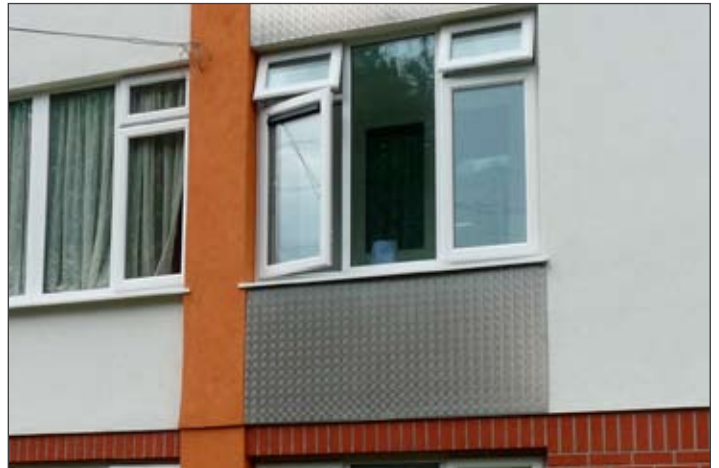
The balconies after refurbishment now portray a fresh modern appearance with the use of metal chequer plate detailing.
