External Wall Insulation

Case Study

Dotcliffe Road, Kelbrook
Lancashire

Sector: Social Housing
Low Rise
Refurbishment

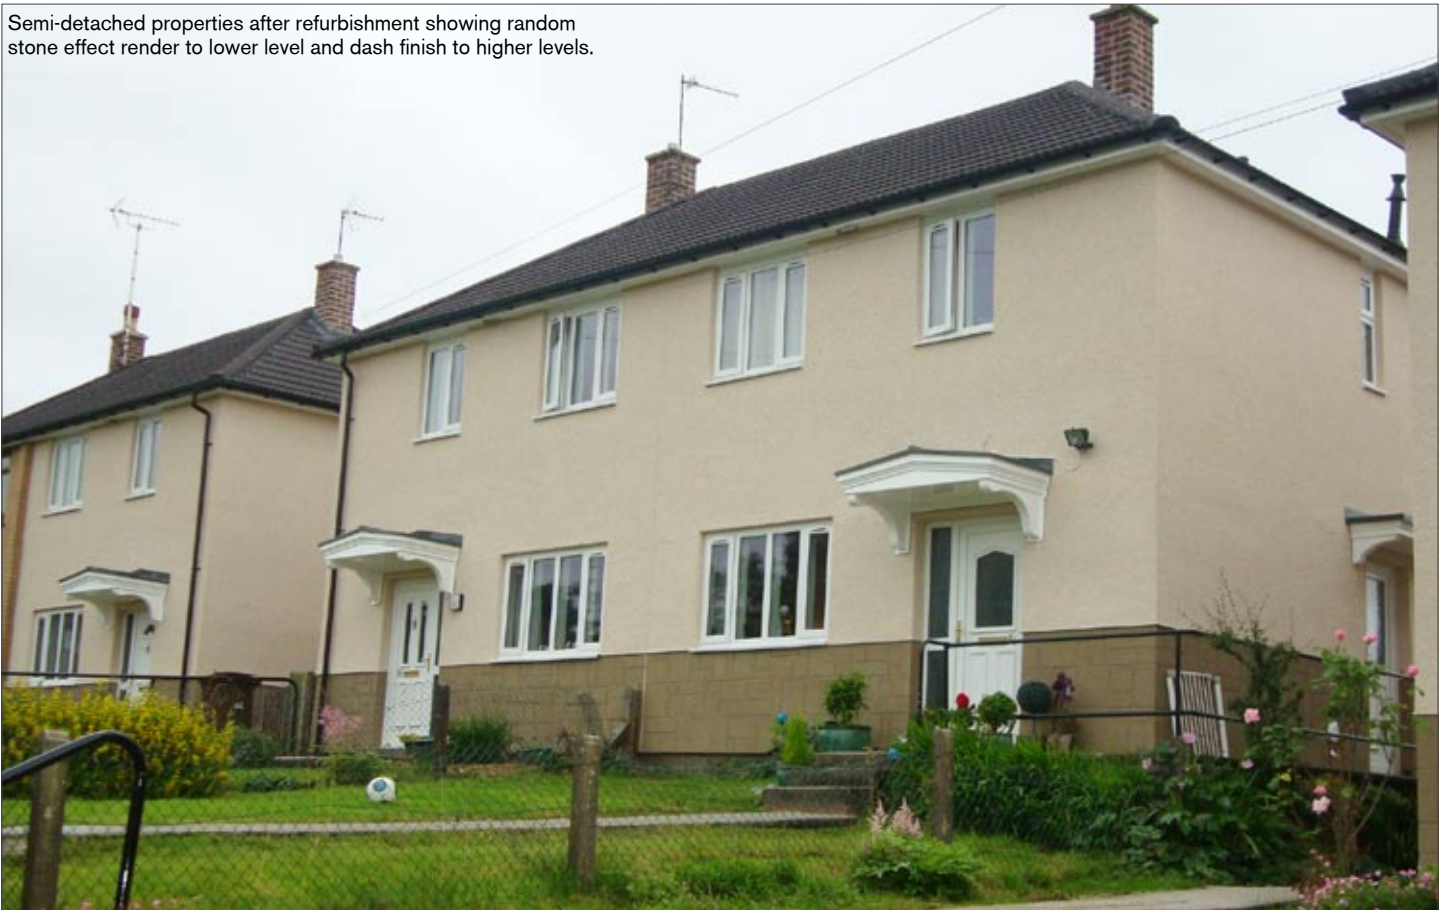
Semi-detached properties after refurbishment showing random stone effect render to lower level and dash finish to higher levels.

Structherm's unique Structural External Wall Insulation (SEWI) system incorporating 105mm thick Enhanced EPS insulation was specified for the external refurbishment of the properties. To complete the system a random stone effect render was applied to the lower ground floors in Old Yorkshire Stone with Keighley Grey mortar. The first floors were then finished in a Beige dash aggregate onto a York Sand dash receiver to significantly improve the appearance of the properties.
