External Wall Insulation

Case Study

St Helens, Merseyside

Sector: Social Housing
Low Rise
Refurbishment

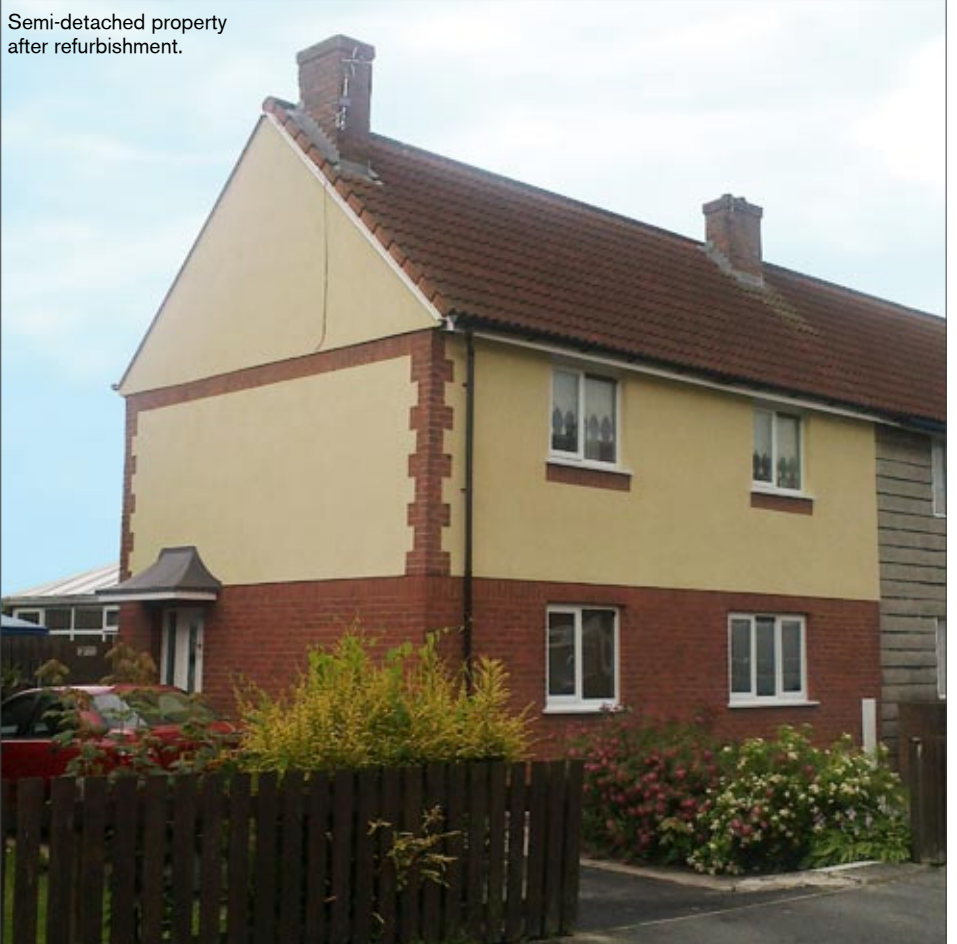
Semi-detached property
after refurbishment.

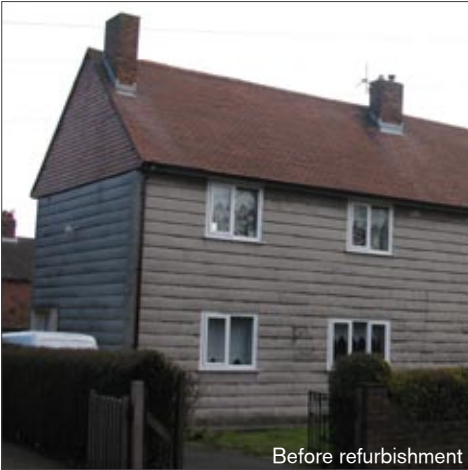
Before refurbishment

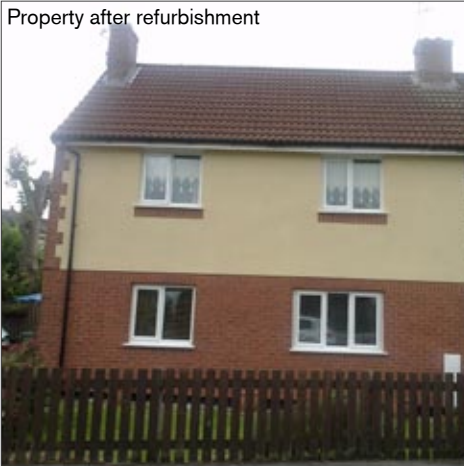
Property after refurbishment

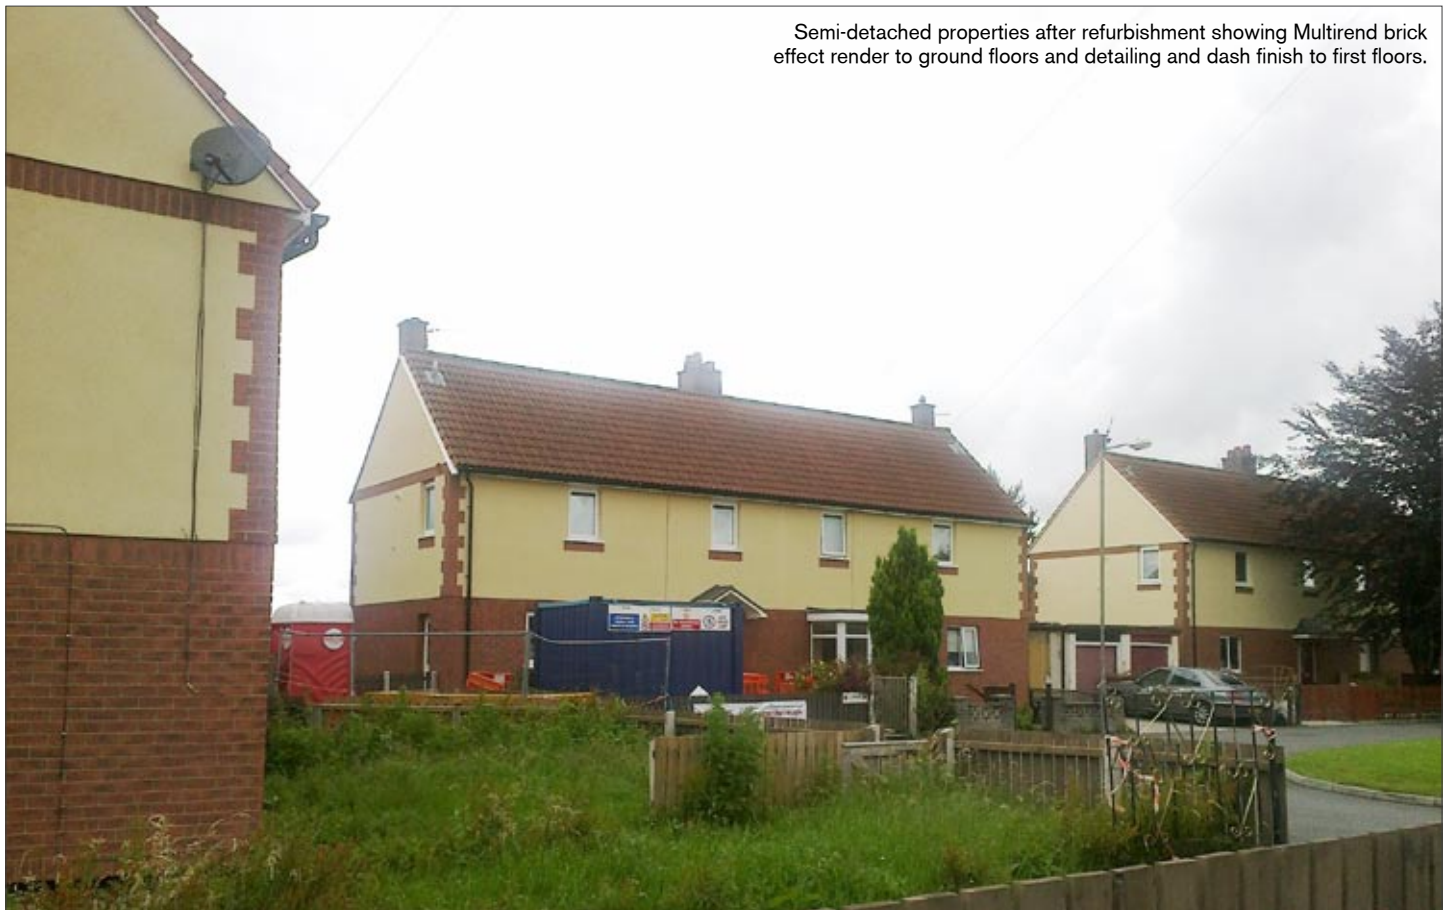
Semi-detached properties after refurbishment showing Multirend brick effect render to ground floors and detailing and dash finish to first floors.

Structherm's unique Structural External Wall Insulation (SEWI) system incorporating 80mm thick Enhanced EPS insulation was specified for the external refurbishment of the properties. To complete the system a Multirend brick effect render was applied to the ground floors and used for detailing on gables, under windows and as quoins. The first floors were then finished in a cream coloured high performance texture coating to significantly improve the appearance of the properties.
