Structherm | Cladding
Greatlands Crescent
North Prospect, Plymouth

Sector: Social Housing
Low Rise
Refurbishment

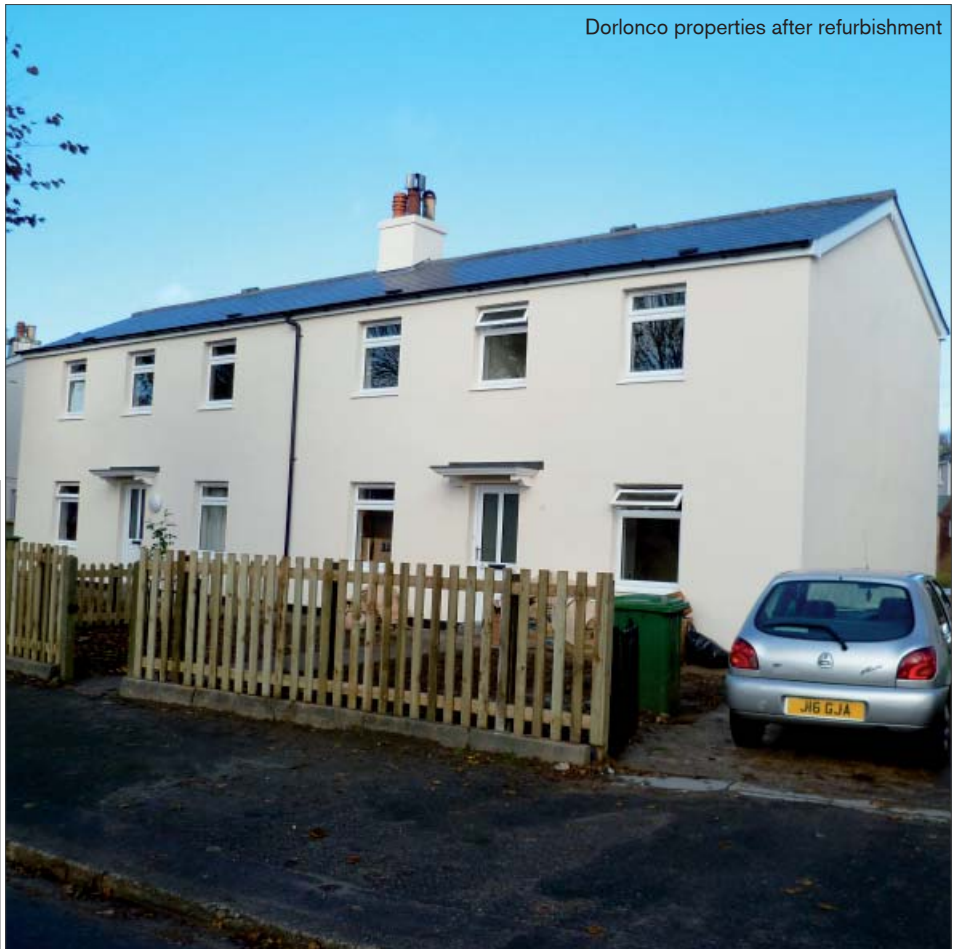
Dorlonco properties after refurbishment

PCH decided to trial Structherm's unique Structural Insulated Cladding system consisting of a 125mm structural panel with Enhanced EPS insulation for the external refurbishment of two Dorlonco properties, before rolling out a full scale programme to the remaining 38 properties. The refurbishment included stripping the outer brick skin and removing the failed cavity wall insulation which had slumped due to water ingress. Then every steel column had its corroded base cut out before a continuous curb stone was laid to form a ring beam base on the newly fitted damp proof membrane. Each column was then fixed using brackets to the curb stone providing the necessary structural support. To complete the refurbishment the structural cladding panels were installed over the columns and then rendered using a high performing Acrylic render.

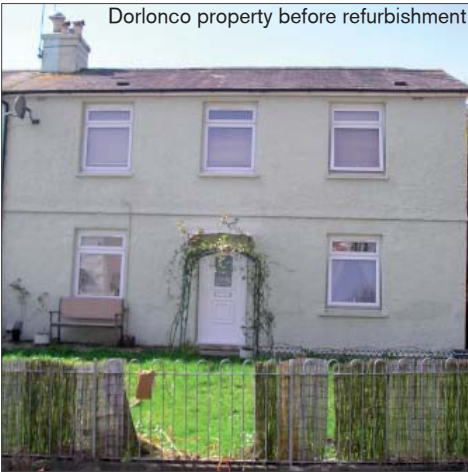
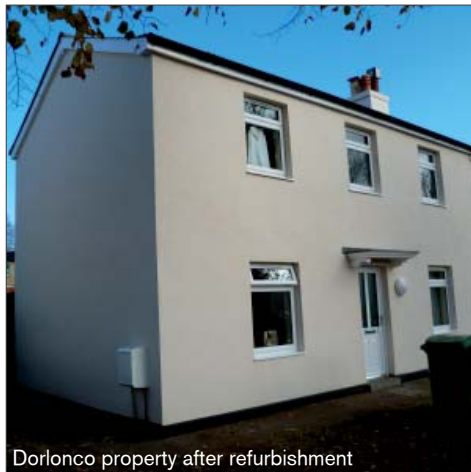
Dorlonco property before refurbishment

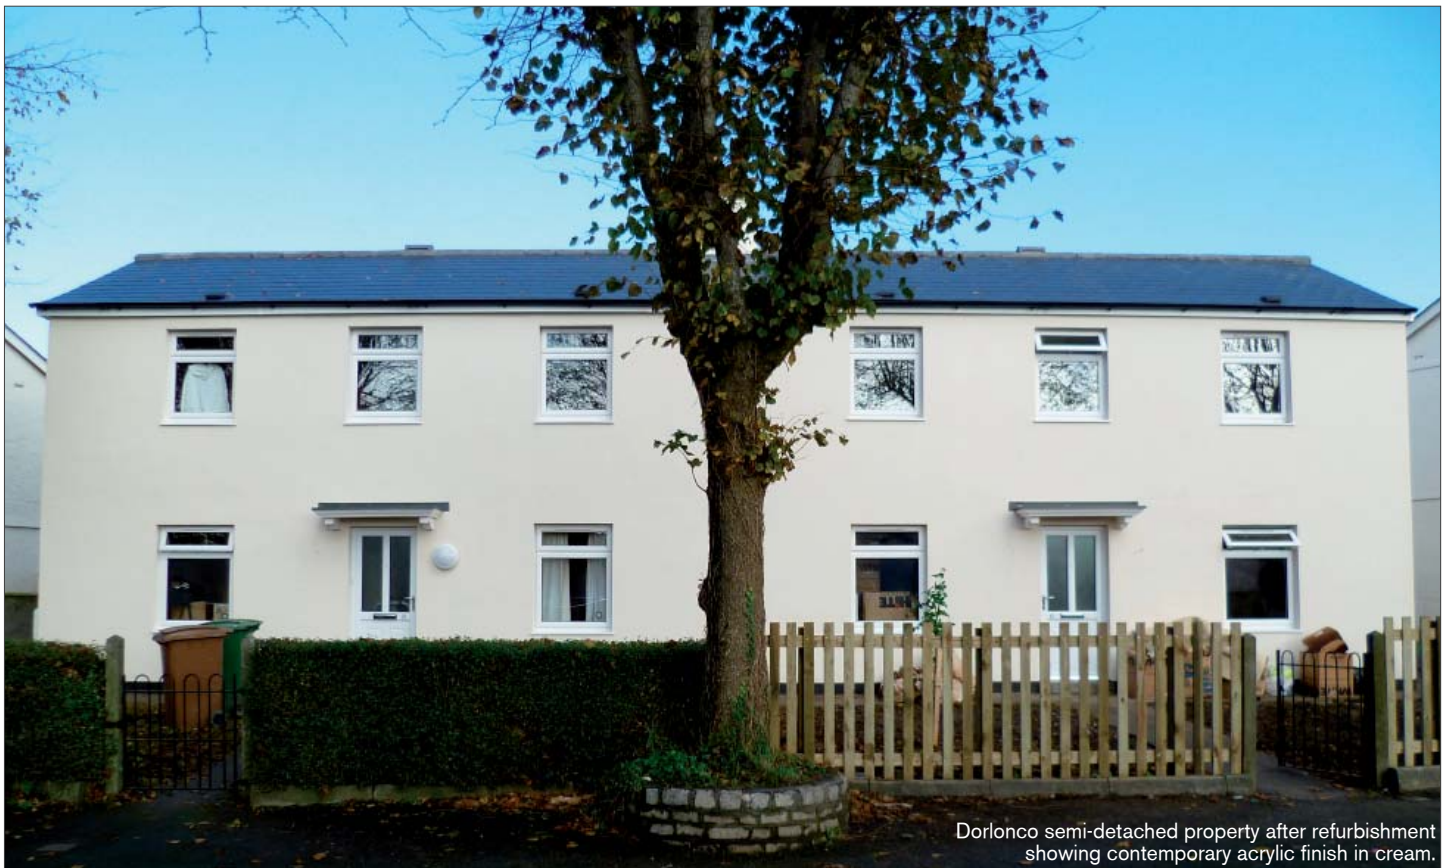
Dorlonco semi-detached property after refurbishment showing contemporary acrylic finish in cream.
